## Access Compliance Report Public Rights-of-Way (Curb Ramps)

Intersection ID: 9723Main Street: J\_JULIAN\_LNCross Street: TUCKASEEGEE\_RDLocation:WADA ID: EEBF57BE1136Ramp Type: PerpInitial Pass/Fail: FailOverall Compliance: NoSeverity Score:10

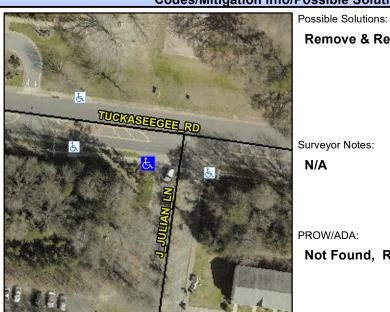
Remove & Replace Entire Ramp.	
	N
	N
	N
	N
	N
Surveyor Notes:	N
N/A	N
	N
	N.
	N.
PROW/ADA:	N
Not Found, R304.5.1, R304.5.3	N
·	N
	N
	N

Field Measurements/Component Compliance								
Comp	liance Description	Data	Comp	liance	Description	Data		
N/A	Ramp Length (in)	65.0	Yes	Ramp	Slope (%)	8.0		
No	Ramp Width (in)	46.5	No	Ramp	XSlope (%)	4.2		
N/A	Flare Type LT	N/A	N/A	Flare	Type RT	N/A		
N/A	Flare Slope LT (%)	N/A	N/A	Flare	Slope RT (%)	N/A		
N/A	Flare Traversable LT?	N/A	N/A	Flare	Traversable RT?	N/A		
N/A	Landing Length (in)	N/A	N/A	DWS	Provided?	N/A		
N/A	Landing Width (in)	N/A	N/A	DWS	Contrast?	N/A		
N/A	Landing Slope (%)	N/A	N/A	DWS	Length (in)	N/A		
N/A	Landing X Slope (%)	N/A	N/A	DWS	Full Width?	N/A		
N/A	Landing Curb? (Y/N)	N/A	N/A	DWS	Offset (in)	N/A		
N/A	Shared Landing?	N/A						
N/A	Gutter Ponding?	N/A	N/A	Gutte	r Slope (%)	N/A		
N/A	Gutter Lip Ht (in)	N/A	N/A	Gutte	r X Slope (%)	N/A		
N/A	Painted X Walk1?	No	N/A	Painte	ed X Walk2?	N/A		
	X Walk 1 Direction	To E		X Wa	lk 2 Direction	N/A		
N/A	X Walk 1 Width (in)	N/A	N/A	X Wa	lk 2 Width (in)	N/A

X Walk 1 Slope (%)	2.3		X Wa	lk 2 Slope (%)	N/A		
	X Walk 1 X Slope (%)	6.7		X Wa	lk 2 X Slope (%)	N/A		
N/A	Ramp inside XWalk1?	N/A	N/A	Ramp	inside XWalk2?	N/A		
	Road Slope (%)	N/A	N/A	Clear	Space?	N/A		
	Road X Slope (%)	N/A	N/A	Clear	Space to XWalk (in)	N/A		
N/A	Any Obstructions?	N/A	N/A	Storm	Grate/Utility Hazard?	N/A		
	Obstruction Type			Storm	Grate/Utility Type			
		N/A				N/A		
			Yes	Surfa	ce Condition? (G/P)	Good
