Access Compliance Report

Public Rights-of-Way

(Curb Ramps)

Intersection ID: N/A	Main Street: YORK_CENTER	Cross Street: N/A	Location: SE
ADA ID: EEC3DD1EEA42	Ramp Type: PerpDiag	Initial Pass/Fail: Fail	Overall Compliance: No
Codes/Mitigation Info/Possible Solution		Field Measurements/Component Compliance	
Severity Score: 10

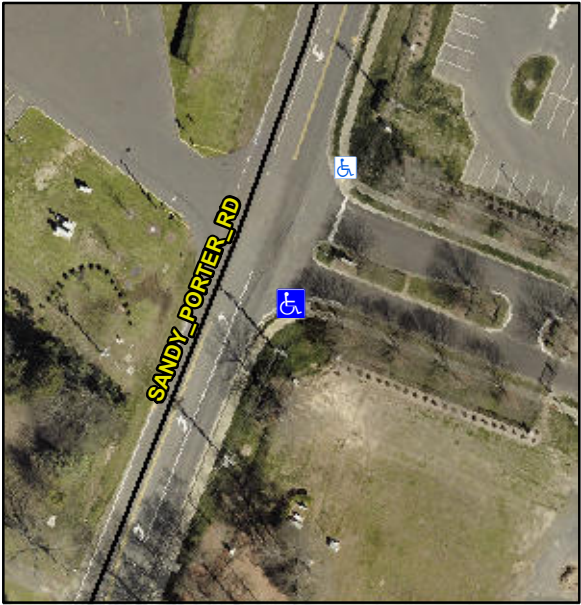
Possible Solutions:	Compliance	Description	Data	Compliance	Description	Data
	Remove & Replace Curb Ramp With Two New Directional Ramps or Equivalent.	N/A	Ramp Length (in)	72.0	Yes	Ramp Slope (%)	6.4
		No	Ramp Width (in)	39.0	No	Ramp XSlope (%)	2.7
		N/A	Flare Type LT	N/A	N/A	Flare Type RT	N/A
		N/A	Flare Slope LT (%)	N/A	N/A	Flare Slope RT (%)	N/A
		N/A	Flare Traversable LT?	N/A	N/A	Flare Traversable RT?	N/A
		N/A	Landing Length (in)	N/A	N/A	DWS Provided?	N/A
		N/A	Landing Width (in)	N/A	N/A	DWS Contrast?	N/A
		N/A	Landing Slope (%)	N/A	N/A	DWS Length (in)	N/A
		N/A	Landing X Slope (%)	N/A	N/A	DWS Full Width?	N/A
<p>Surveyor Notes:</p> <p>N/A</p> <p>PROW/ADA:</p> <p>Not Found, R304.5.1, R304.5.3</p>		N/A	Landing Curb? (Y/N)	N/A	N/A	DWS Offset (in)	N/A
		N/A	Shared Landing?	N/A			
		N/A	Gutter Ponding?	N/A	N/A	Gutter Slope (%)	N/A
		N/A	Gutter Lip Ht (in)	N/A	N/A	Gutter X Slope (%)	N/A
		N/A	Painted X Walk1?	No	N/A	Painted X Walk2?	No

X Walk 1 Direction	To NE		X Walk 2 Direction	To NW
		N/A	X Walk 1 Width (in)	N/A	N/A	X Walk 2 Width (in)	N/A
			X Walk 1 Slope (%)	0.4		X Walk 2 Slope (%)	1.4
			X Walk 1 X Slope (%)	1.3		X Walk 2 X Slope (%)	0.3
		N/A	Ramp inside XWalk1?	N/A	N/A	Ramp inside XWalk2?	N/A
<p>Street 1 Name</p> <p>Stop Condition-Street 2</p> <p>Street 2 Name</p> <p>Stop Condition-Street 1</p>			Road Slope (%)	0.4	N/A	Clear Space?	N/A
			Road X Slope (%)	2.4	N/A	Clear Space to XWalk (in)	N/A
		N/A	Any Obstructions?	N/A	N/A	Storm Grate/Utility Hazard?	N/A
			Obstruction Type			Storm Grate/Utility Type	
					N/A		N/A
					Yes	Surface Condition? (G/P)	Good
Total Cost:		\$	3200.00
