Access Compliance Report Public Rights-of-Way (Curb Ramps)

Intersection ID: 14785 Main Street: ALBERTO_ST Cross Street: CIRCLE_AV Location: NE

ADA ID: EEC9E93EE1D8 Ramp Type: PerpDiag Initial Pass/Fail: Fail Overall Compliance: No Severity Score: 13.75

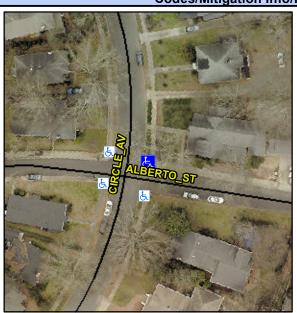
Not Found, R304.2.2, R304.5.3

r leid Measurements/Component Compnance						
Compliance Description		Data	Compliance Description		Data	
N/A	Ramp Length (in)	74.0	No	Ramp Slope (%)	9.5	
Yes	Ramp Width (in)	48.0	No	Ramp XSlope (%)	2.6	
N/A	Flare Type LT	N/A	N/A	Flare Type RT	N/A	
N/A	Flare Slope LT (%)	N/A	N/A	Flare Slope RT (%)	N/A	
N/A	Flare Traversable LT?	N/A	N/A	Flare Traversable RT?	N/A	
N/A	Landing Length (in)	N/A	N/A	DWS Provided?	N/A	
N/A	Landing Width (in)	N/A	N/A	DWS Contrast?	N/A	
N/A	Landing Slope (%)	N/A	N/A	DWS Length (in)	N/A	
N/A	Landing X Slope (%)	N/A	N/A	DWS Full Width?	N/A	
N/A	Landing Curb? (Y/N)	N/A	N/A	DWS Offset (in)	N/A	
N/A	Shared Landing?	N/A				
N/A	Gutter Ponding?	N/A	N/A	Gutter Slope (%)	N/A	
N/A	Gutter Lip Ht (in)	N/A	N/A	Gutter X Slope (%)	N/A	
N/A	Painted X Walk1?	No	N/A	Painted X Walk2?	No	
	X Walk 1 Direction	To NW		X Walk 2 Direction	To SW	
N/A	X Walk 1 Width (in)	N/A	N/A	X Walk 2 Width (in)	N/A	
	X Walk 1 Slope (%)	4.6		X Walk 2 Slope (%)	5.2

X Walk 1 X Slope (%)	2.9		X Walk 2 X Slope (%)	0.7	
N/A	Ramp inside XWalk1?	N/A	N/A	Ramp inside XWalk2?	N/A	
	Road Slope (%)	0.3	N/A	Clear Space?	N/A	
	Road X Slope (%)	5.4	N/A	Clear Space to XWalk (in)	N/A

Remove & Replace Curb Ramp With Two New Directional Ramps or Equivalent.
