# Access Compliance Report

## Public Rights-of-Way (Curb Ramps)

Intersection ID: 12017	Main Street: S I-77 EXIT 10A RA	Cross Street: W MOREHEAD ST	Location: SW
ADA ID: EECCF39D0572	Ramp Type: Combination1	Initial Pass/Fail: Pass	Overall Compliance: No Severity Score: 10.25

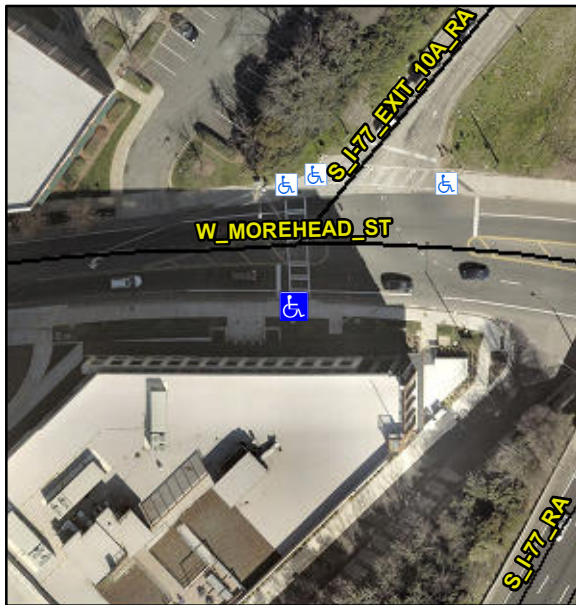
**LT RP < 5%**

**Not Found, R304.5.3, R304.2.1,  
R304.2.2-Perp, R304.3.2-Para**

Compliance	Description	Data	Compliance	Description	Data
N/A	Ramp Length LT (in)	89.0	N/A	Ramp Length RT (in)	91.0
Yes	Ramp Width LT (in)	66.0	Yes	Ramp Width RT (in)	66.0
Yes	Ramp Slope LT (%)	3.8	Yes	Ramp Slope RT (%)	6.4
No	Ramp XSlope LT (%)	3.2	No	Ramp XSlope RT (%)	4.0
N/A	Ramp Length (in)	66.0	Yes	Ramp Slope (%)	7.4
Yes	Ramp Width (in)	48.0	Yes	Ramp XSlope (%)	1.6
N/A	Flare Type LT	Sloped	N/A	Flare Type RT	Sloped
Yes	Flare Slope LT (%)	2.6	Yes	Flare Slope RT (%)	7.1
N/A	Flare Traversable LT?	Yes	N/A	Flare Traversable RT?	Yes
No	Landing Length (in)	N/A	Yes	DWS Provided?	Yes
No	Landing Width (in)	N/A	Yes	DWS Contrast?	Yes
No	Landing Slope (%)	N/A	Yes	DWS Length (in)	25.5
No	Landing X Slope (%)	N/A	Yes	DWS Full Width?	Yes
N/A	Landing Curb? (Y/N)	No	Yes	DWS Offset (in)	2.0
N/A	Shared Landing?	No			
Yes	Gutter Ponding?	No	Yes	Gutter Slope (%)	1.4
Yes	Gutter Lip Ht (in)	0.0	Yes	Gutter X Slope (%)	1.9
N/A	Painted X Walk1?	Yes	N/A	Painted X Walk2?	N/A

**Remove & Replace Entire Ramp.  
Remove & Replace Sidewalk.**
