Access Compliance Report

Public Rights-of-Way (Curb Ramps)

Intersection ID: 53635	Main Street: NEWBURY GROVE ST	Cross Street: TREMONT RIDGE CT	Location: NW
ADA ID: EED65B408A1D	Ramp Type: Directional1	Initial Pass/Fail: Fail	Overall Compliance: No
		Severity Score: 12.5

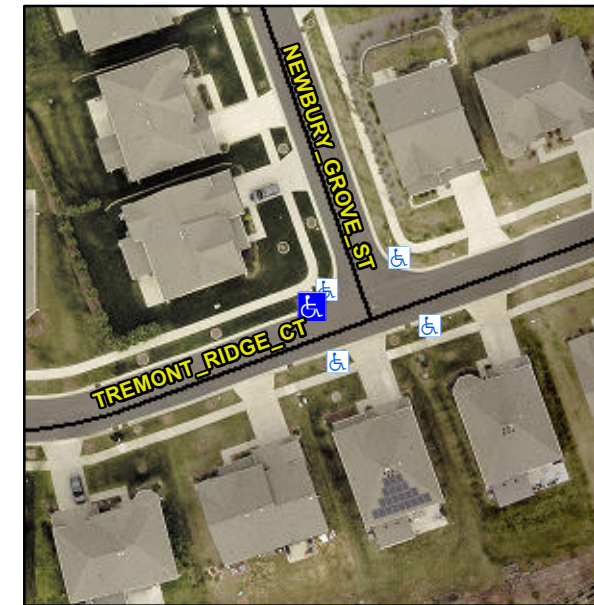
Compliance	Description	Data	Compliance	Description	Data
N/A	Ramp Length (in)	89.0	N/A	Grade Break?	N/A
Yes	Ramp Width (in)	60.0	N/A	Grade Break Slope (%)	0.0
Yes	Ramp Slope (%)	7.8	N/A	Grade Break XSlope (%)	0.0
No	Ramp XSlope (%)	5.1			
N/A	Flare Type LT	N/A	N/A	Flare Type RT	N/A
N/A	Flare Slope LT (%)	N/A	N/A	Flare Slope RT (%)	0.0
N/A	Flare Traversable LT?	N/A	N/A	Flare Traversable RT?	N/A
N/A	Landing Length (in)	0.0	N/A	DWS Provided?	N/A
N/A	Landing Width (in)	0.0	N/A	DWS Contrast?	N/A
N/A	Landing Slope (%)	0.0	N/A	DWS Length (in)	N/A
N/A	Landing X Slope (%)	0.0	N/A	DWS Full Width?	N/A
N/A	Landing Curb? (Y/N)	N/A	N/A	DWS Offset LT (in)	N/A
N/A	Shared Landing?	N/A	N/A	DWS Offset RT (in)	N/A
N/A	Gutter Ponding?	0.0	N/A	Gutter Slope (%)	N/A
N/A	Gutter Lip Ht (in)	0.0	N/A	Gutter X Slope (%)	N/A
N/A	Painted X Walk1?	No		Road Slope (%)	7.4
	X Walk 1 Direction	To SE		Road X Slope (%)	0.8
	X Walk 1 Width (in)	N/A		Clear Space?	N/A

X Walk 1 Slope (%)	7.4	N/A	Clear Space to XWalk (in)	N/A
	X Walk 1 X Slope (%)	0.8	N/A	Storm Grate/Utility Hazard?	N/A
N/A	Ramp inside XWalk1?	N/A		Storm Grate/Utility Type	
N/A	Any Obstructions?	N/A			N/A
	Obstruction Type		Yes	Surface Condition? (G/P)	Good
			N/A	Curb Slope (%)	5.3

Possible Solutions:

Remove & Replace Entire Ramp.

PROW/ADA:

R304.5.3
