Access Compliance Report Public Rights-of-Way (Curb Ramps)

Intersection ID: 14356	Main Street: BAXTER_ST		Cross Street: S_TORRENCE_ST				Location: E		
ADA ID: EF016599B4A5	Ramp Type: PerpDiag			Initial Pass/Fail: Fail Overall Complian			nce: No Severity Score: 21.25		21.25
Codes/Mitigation Info/Possible Solution				Field Measurements/Component Compliance					
	des/mitigation mo	Possible Solutions:		Compliance Description Data Compliance Description Data					
		Remove & Replace Curb Ramp With Two New Directional Ramps or Equivalent.	V:+h	N/A	Ramp Length (in)	60.0	No	Ramp Slope (%)	9.5
			VILII	No	Ramp Width (in)	43.0	Yes	Ramp XSlope (%)	3.3 1.1
				N/A	Flare Type LT	43.0 N/A	N/A	Flare Type RT	N/A
				N/A	Flare Slope LT (%)	N/A	N/A	Flare Slope RT (%)	N/A
				N/A	Flare Traversable LT?	N/A	N/A	Flare Traversable RT?	N/A
Par Internet				N/A	Landing Length (in)	N/A	N/A	DWS Provided?	N/A N/A
Contraction Contraction	A State State			N/A	Landing Width (in)	N/A	N/A	DWS Contrast?	N/A N/A

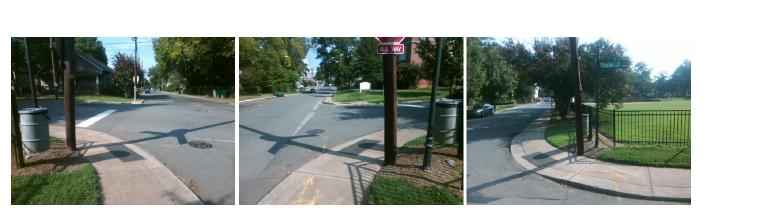
N/A	o ()	N/A	N/A		N/A N/A
		N/A			Landing Slope (%)			DWS Length (in)	
				N/A	Landing X Slope (%)	N/A	N/A	DWS Full Width?	N/A
		5 8		N/A	Landing Curb? (Y/N)	N/A	N/A	DWS Offset (in)	N/A
				N/A	Shared Landing?	N/A			
		PROW/ADA:		N/A	Gutter Ponding?	N/A	N/A	Gutter Slope (%)	N/A
		Not Found, R304.5.1, R304.2.2		N/A	Gutter Lip Ht (in)	N/A	N/A	Gutter X Slope (%)	N/A
				N/A	Painted X Walk1?	No	N/A	Painted X Walk2?	No
					X Walk 1 Direction	To NW		X Walk 2 Direction	To SW
				N/A	X Walk 1 Width (in)	N/A	N/A	X Walk 2 Width (in)	N/A
Street 1 Name	S TORRENCE ST				X Walk 1 Slope (%)	1.7		X Walk 2 Slope (%)	2.2
Stop Condition-Street 2	StopSign				X Walk 1 X Slope (%)	3.2		X Walk 2 X Slope (%)	2.0
Street 2 Name	BAXTER ST			N/A	Ramp inside XWalk1?	N/A	N/A	Ramp inside XWalk2?	N/A
Stop Condition-Street 1	StopSign				Road Slope (%)	1.3	N/A	Clear Space?	N/A
					Road X Slope (%)	1.8	N/A	Clear Space to XWalk (in)	N/A

Yes Surface Condition? (G/P)

Good

N/A	Any Obstructions?	N/A		Storm Grate/Utility Hazard?	N/A
		Total Cost: \$ 3	200.00		Obstruction Type			Storm Grate/Utility Type	
		····· • •				N/A			N/A
						IN/A	I		17/7
