Access Compliance Report

Public Rights-of-Way

(Curb Ramps)

Intersection ID: 13911	Main Street: LEXINGTON_AV	Cross Street: ORIOLE_AV	Location: E
ADA ID: EF0528127359	Ramp Type: Perp	Initial Pass/Fail: Fail	Overall Compliance: No
		Severity Score: 1.25

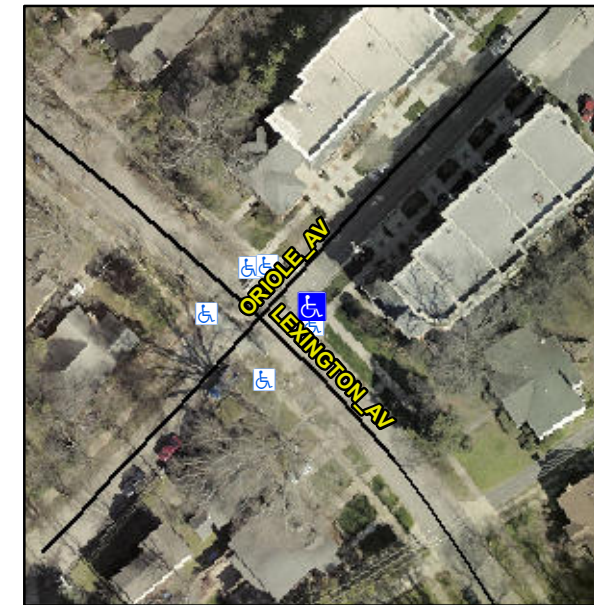
Not Found, R304.5.3

Compliance	Description	Data	Compliance	Description	Data
N/A	Ramp Length (in)	68.0	Yes	Ramp Slope (%)	5.1
Yes	Ramp Width (in)	48.0	No	Ramp XSlope (%)	4.2
N/A	Flare Type LT	N/A	N/A	Flare Type RT	N/A
N/A	Flare Slope LT (%)	N/A	N/A	Flare Slope RT (%)	N/A
N/A	Flare Traversable LT?	N/A	N/A	Flare Traversable RT?	N/A
N/A	Landing Length (in)	N/A	N/A	DWS Provided?	N/A
N/A	Landing Width (in)	N/A	N/A	DWS Contrast?	N/A
N/A	Landing Slope (%)	N/A	N/A	DWS Length (in)	N/A
N/A	Landing X Slope (%)	N/A	N/A	DWS Full Width?	N/A
N/A	Landing Curb? (Y/N)	N/A	N/A	DWS Offset (in)	N/A
N/A	Shared Landing?	N/A			
N/A	Gutter Ponding?	N/A	N/A	Gutter Slope (%)	N/A
N/A	Gutter Lip Ht (in)	N/A	N/A	Gutter X Slope (%)	N/A
N/A	Painted X Walk1?	No	N/A	Painted X Walk2?	N/A
	X Walk 1 Direction	To NW		X Walk 2 Direction	N/A
N/A	X Walk 1 Width (in)	N/A	N/A	X Walk 2 Width (in)	N/A
	X Walk 1 Slope (%)	1.0		X Walk 2 Slope (%)	N/A
	X Walk 1 X Slope (%)	1.2		X Walk 2 X Slope (%)	N/A

Remove & Replace Entire Ramp.

Total Cost: \$ 1850.00
