# Access Compliance Report

## Public Rights-of-Way (Curb Ramps)

Intersection ID: 30513	Main Street: S_TRYON_ST	Cross Street: GENERAL_DR	Location: SW
ADA ID: EF1C9D7314E8	Ramp Type: PerpDiag	Initial Pass/Fail: Fail	Overall Compliance: No
		Severity Score: 12.5

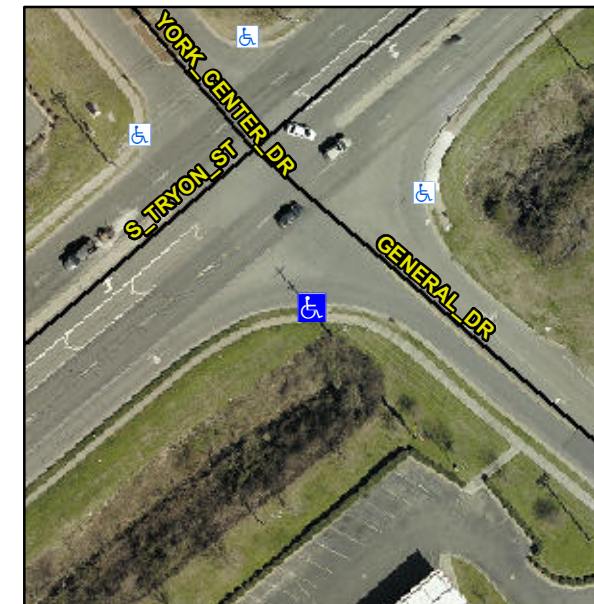
Compliance	Description	Data	Compliance	Description	Data
N/A	Ramp Length (in)	90.0	No	Ramp Slope (%)	9.1
Yes	Ramp Width (in)	48.0	Yes	Ramp XSlope (%)	1.6
N/A	Flare Type LT	N/A	N/A	Flare Type RT	N/A
N/A	Flare Slope LT (%)	N/A	N/A	Flare Slope RT (%)	N/A
N/A	Flare Traversable LT?	N/A	N/A	Flare Traversable RT?	N/A
N/A	Landing Length (in)	N/A	N/A	DWS Provided?	N/A
N/A	Landing Width (in)	N/A	N/A	DWS Contrast?	N/A
N/A	Landing Slope (%)	N/A	N/A	DWS Length (in)	N/A
N/A	Landing X Slope (%)	N/A	N/A	DWS Full Width?	N/A
N/A	Landing Curb? (Y/N)	N/A	N/A	DWS Offset (in)	N/A
N/A	Shared Landing?	N/A			
N/A	Gutter Ponding?	N/A	N/A	Gutter Slope (%)	N/A
N/A	Gutter Lip Ht (in)	N/A	N/A	Gutter X Slope (%)	N/A
N/A	Painted X Walk1?	No	N/A	Painted X Walk2?	No
	X Walk 1 Direction	To NE		X Walk 2 Direction	To N
N/A	X Walk 1 Width (in)	N/A	N/A	X Walk 2 Width (in)	N/A
	X Walk 1 Slope (%)	3.0		X Walk 2 Slope (%)	1.5
	X Walk 1 X Slope (%)	0.1		X Walk 2 X Slope (%)	2.5

N/A	Ramp inside XWalk1?	N/A	N/A	Ramp inside XWalk2?	N/A
	Road Slope (%)	1.8	N/A	Clear Space?	N/A
	Road X Slope (%)	1.9	N/A	Clear Space to XWalk (in)	N/A
N/A	Any Obstructions?	N/A	N/A	Storm Grate/Utility Hazard?	N/A
	Obstruction Type			Storm Grate/Utility Type	
		N/A			N/A
			Yes	Surface Condition? (G/P)	Good

**Remove & Replace Curb Ramp With Two New Directional Ramps or Equivalent.**

**R304.2.2**

**\$ 3200.00**
