# Access Compliance Report

## Public Rights-of-Way

### (Curb Ramps)

Intersection ID: 26087	Main Street: CARMEL_CROSSING_RD	Cross Street: JOHNSTON_RD	Location: NW
ADA ID: EF1DA35B1802	Ramp Type: BlendTrans2	Initial Pass/Fail: Fail	Overall Compliance: No
		Severity Score: 10

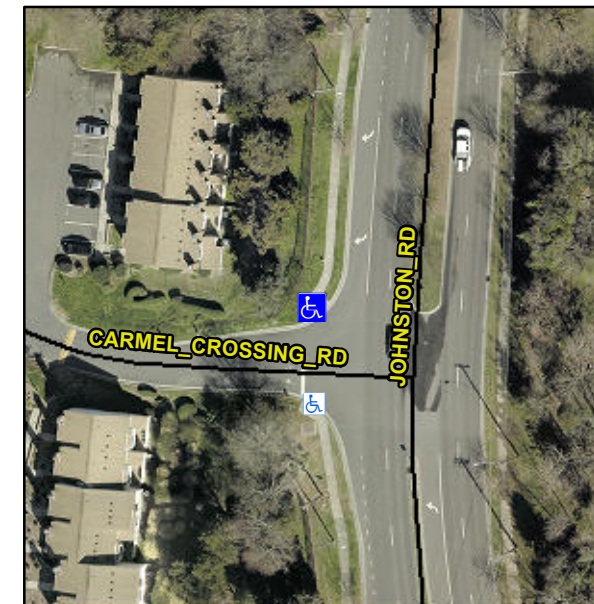
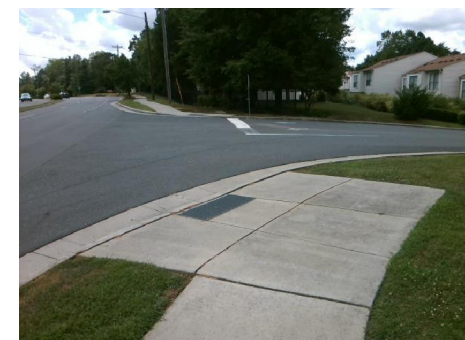
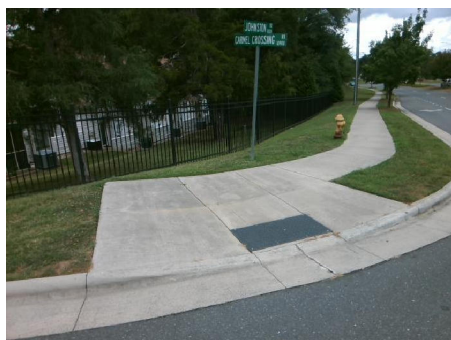
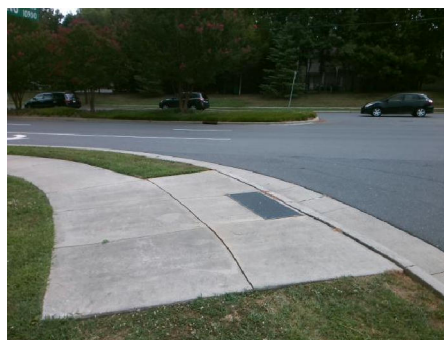
**Not Found, R304.5.1, R304.5.3**

Compliance	Description	Data	Compliance	Description	Data
N/A	Ramp Length (in)	123.0	Yes	BlendTrans Slope (%)	4.0
No	Ramp Width (in)	46.5	No	BlendTrans XSlope (%)	3.0
N/A	Flare Type LT	N/A	N/A	Flare Type RT	N/A
N/A	Flare Slope LT (%)	N/A	N/A	Flare Slope RT (%)	N/A
N/A	Flare Traversable LT?	N/A	N/A	Flare Traversable RT?	N/A
N/A	Landing Length (in)	N/A	N/A	DWS Provided?	N/A
N/A	Landing Width (in)	N/A	N/A	DWS Contrast?	N/A
N/A	Landing Slope (%)	N/A	N/A	DWS Length (in)	N/A
N/A	Landing X Slope (%)	N/A	N/A	DWS Full Width?	N/A
N/A	Landing Curb? (Y/N)	N/A	N/A	DWS Offset (in)	N/A
N/A	Shared Landing?	N/A			
N/A	Gutter Ponding?	N/A	N/A	Gutter Slope (%)	N/A
N/A	Gutter Lip Ht (in)	N/A	N/A	Gutter X Slope (%)	N/A
N/A	Painted X Walk1?	No	N/A	Painted X Walk2?	No
	X Walk 1 Direction	To S		X Walk 2 Direction	To E
	X Walk 1 Width (in)	N/A		X Walk 2 Width (in)	N/A
	X Walk 1 Slope (%)	7.6		X Walk 2 Slope (%)	8.2
	X Walk 1 X Slope (%)	0.8		X Walk 2 X Slope (%)	2.1

N/A	Ramp inside XWalk1?	N/A	N/A	Ramp inside XWalk2?	N/A
	Road Slope (%)	0.2		Clear Space?	N/A
	Road X Slope (%)	1.4	N/A	Clear Space to XWalk (in)	N/A
N/A	Any Obstructions?	N/A	N/A	Storm Grate/Utility Hazard?	N/A
	Obstruction Type			Storm Grate/Utility Type	
		N/A			N/A
			Yes	Surface Condition? (G/P)	Good
			No	Curb Slope (%)	11.4

**Remove & Replace Curb Ramp With Two New Directional Ramps or Equivalent.**
