Access Compliance Report Public Rights-of-Way (Curb Ramps)

Intersection ID: 27431 Main Street: BALLANTYNE_COMMONS_PY Cross Street: RUSHMORE_DR Location: NW
ADA ID: EF287E30799B Ramp Type: Perp Initial Pass/Fail: Fail Overall Compliance: No Severity Score: 10

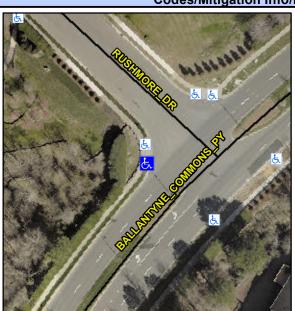
Not Found, R304.5.1, R304.5.3

Field Measurements/Component Compliance						
Compl	iance Description	Data	Comp	iance	Description	Data
N/A	Ramp Length (in)	110.0	Yes	Ramp	Slope (%)	6.8
No	Ramp Width (in)	43.0	No	Ramp	XSlope (%)	3.8
N/A	Flare Type LT	N/A	N/A	Flare	Type RT	N/A
N/A	Flare Slope LT (%)	N/A	N/A	Flare	Slope RT (%)	N/A
N/A	Flare Traversable LT?	N/A	N/A	Flare	Traversable RT?	N/A
N/A	Landing Length (in)	N/A	N/A	DWS	Provided?	N/A
N/A	Landing Width (in)	N/A	N/A	DWS	Contrast?	N/A
N/A	Landing Slope (%)	N/A	N/A	DWS	Length (in)	N/A
N/A	Landing X Slope (%)	N/A	N/A	DWS	Full Width?	N/A
N/A	Landing Curb? (Y/N)	N/A	N/A	DWS	Offset (in)	N/A
N/A	Shared Landing?	N/A				
N/A	Gutter Ponding?	N/A	N/A	Gutte	r Slope (%)	N/A
N/A	Gutter Lip Ht (in)	N/A	N/A	Gutte	r X Slope (%)	N/A
N/A	Painted X Walk1?	No	N/A	Paint	ed X Walk2?	N/A
	X Walk 1 Direction	To SE		X Wa	lk 2 Direction	N/A
N/A	X Walk 1 Width (in)	N/A	N/A	X Wa	lk 2 Width (in)	N/A
	X Walk 1 Slope (%)	1.2		X Wa	lk 2 Slope (%)	N/A

X Walk 1 X Slope (%)	1.0		X Wa	lk 2 X Slope (%)	N/A
N/A	Ramp inside XWalk1?	N/A	N/A	Ramp	inside XWalk2?	N/A
	Road Slope (%)	N/A	N/A	Clear	Space?	N/A
	Road X Slope (%)	N/A	N/A	Clear	Space to XWalk (in)	N/A
N/A	Any Obstructions?	N/A	N/A	Storm	n Grate/Utility Hazard?	N/A
	Obstruction Type			Storm	Grate/Utility Type	
		N/A				N/A
			Yes	Surfa	ce Condition? (G/P)	Good

Possible Solutions:

Remove & Replace Entire Ramp.

Total Cost: \$ 1850.00
