# Access Compliance Report

## Public Rights-of-Way

### (Curb Ramps)

| Intersection ID: 10336 | Main Street: CALLAHAN_ST | Cross Street: POLK_ST | Location: S |

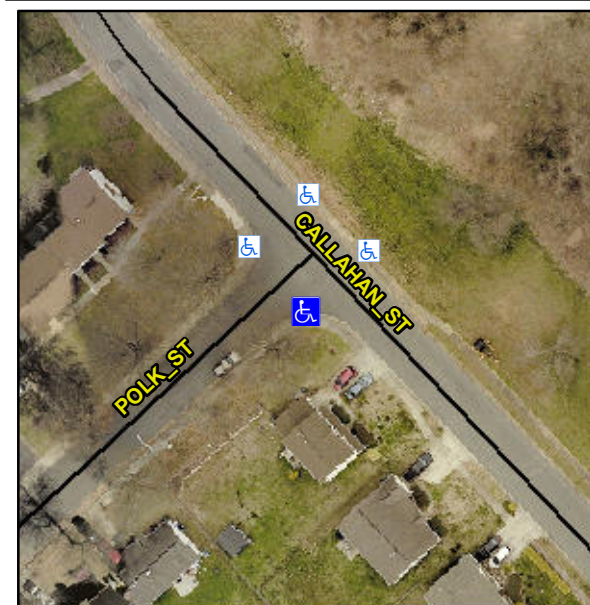
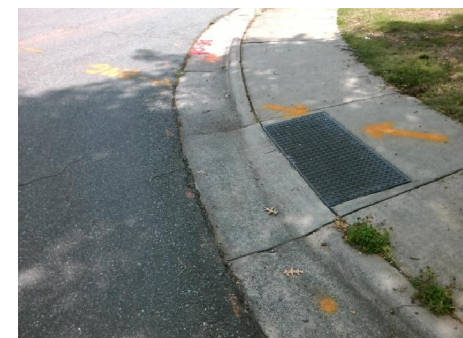
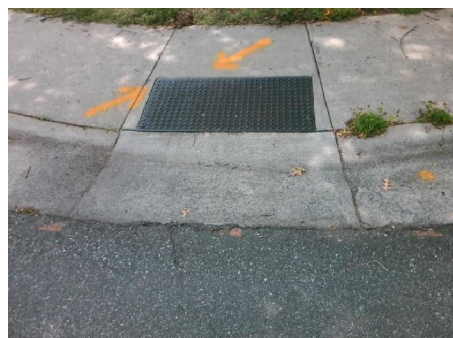
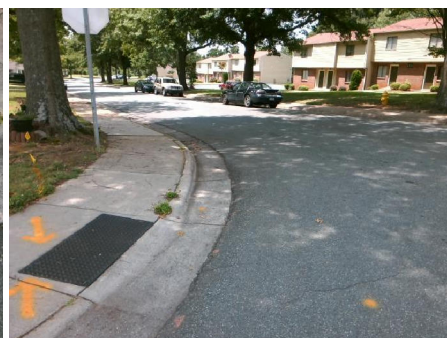
**Not Found, R304.2.1, R304.2.2-Perp, R304.3.2-Para, R304.5.3, R305.1.4, R302.7, R302.7.2**

| Compliance | Description | Data | Compliance | Description | Data |
|---|---|---|---|---|---|
| No | Landing Length (in) | N/A | Yes | DWS Provided? | Yes |
| No | Landing X Slope (%) | N/A | No | DWS Full Width? | No |
| No | Gutter Ponding? | Yes | Yes | Gutter Slope (%) | 0.0 |
| No | Gutter Lip Ht (in) | 1.5 | Yes | Gutter X Slope (%) | 1.3 |

**Remove & Replace Curb Ramp With Two New Directional Ramps or Equivalent.**
