# Access Compliance Report

## Public Rights-of-Way

### (Curb Ramps)

| Intersection ID: 10041482 | Main Street: WESTPARK_DR | Cross Street: N/A | Location: NE |

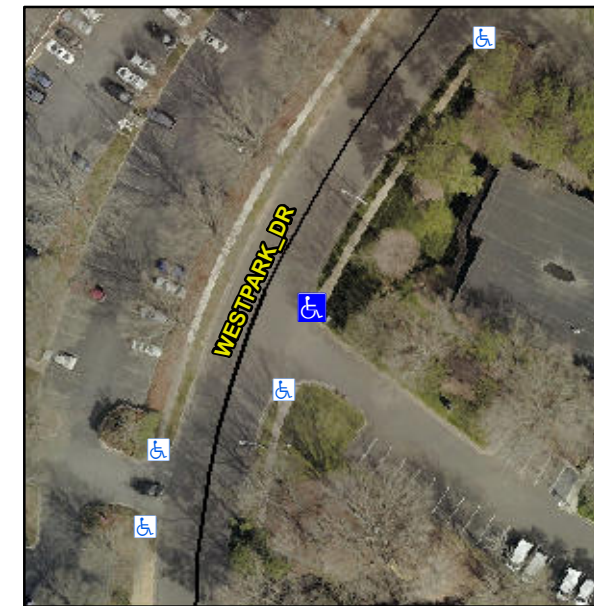
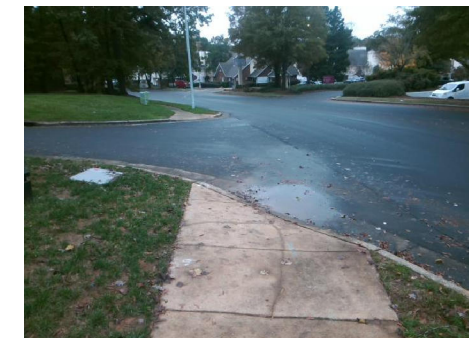
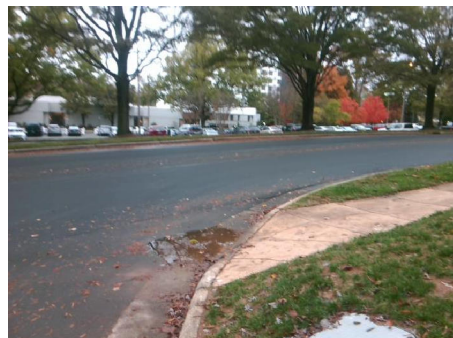
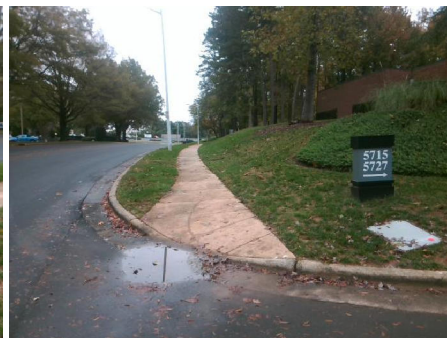
**Not Found, R304.2.2, R304.5.3**

| Compliance | Description | Data | Compliance | Description | Data |
|---|---|---|---|---|---|
| N/A | Ramp Length (in) | 58.0 | No | Ramp Slope (%) | 14.9 |
| Yes | Ramp Width (in) | 48.0 | No | Ramp XSlope (%) | 5.5 |
| N/A | Gutter Ponding? | Yes | N/A | Gutter Slope (%) | N/A |

**Remove & Replace Curb Ramp With Two New Directional Ramps or Equivalent.**
