# Access Compliance Report

### (Curb Ramps)

| Intersection ID: 27411 | Main Street: BALLANTYNE_COMMONS_PY | Cross Street: BALLANTYNE_CORPORATE_PL | Location: SE |
| ADA ID: EF457DF5F130 | Ramp Type: Perp | Initial Pass/Fail: Pass | Overall Compliance: No |

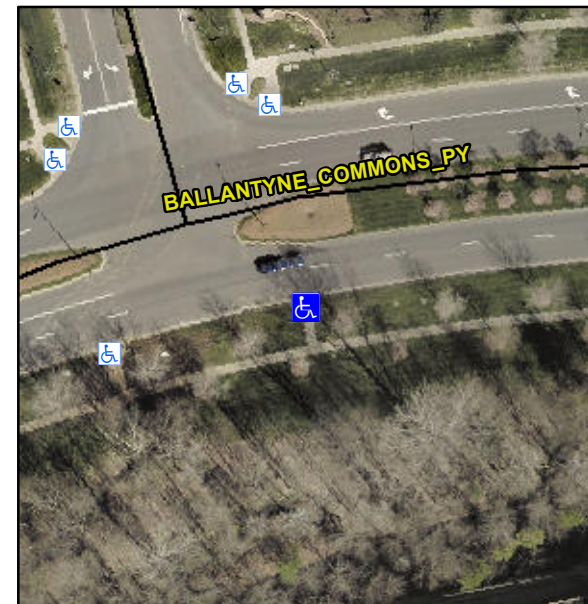
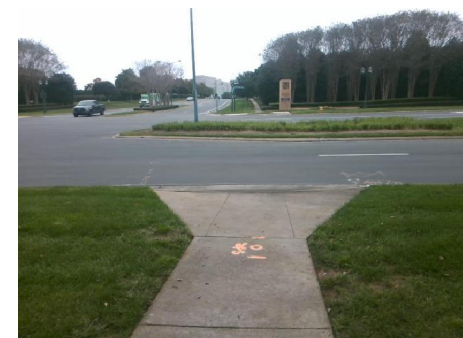
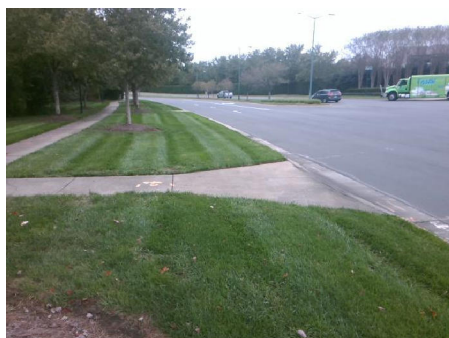
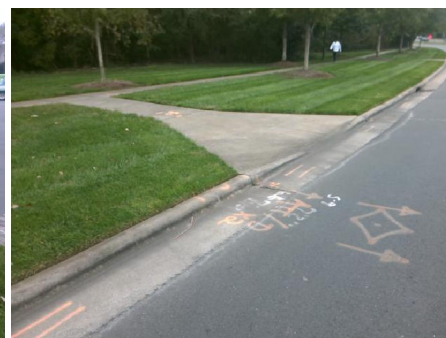
**Not Found, R305, R302.7.2, R304.5.4**

| Compliance | Description | Data | Compliance | Description | Data |
|---|---|---|---|---|---|
| Yes | Landing Length (in) | 77.0 | No | DWS Provided? | No |
| Yes | Gutter Ponding? | No | No | Gutter Slope (%) | 5.4 |
| No | Gutter Lip Ht (in) | 0.5 | Yes | Gutter X Slope (%) | 2.3 |

**Remove & Replace Entire Ramp.  
Remove & Replace Gutter.**
