# Access Compliance Report

## Public Rights-of-Way

### (Curb Ramps)

Intersection ID: 44909	Main Street: PALUSTRIS_CT	Cross Street: OAKBURN_DR	Location: NE
ADA ID: EF4F225D78A9	Ramp Type: PerpDiag	Initial Pass/Fail: Fail	Overall Compliance: No
		Severity Score: 10

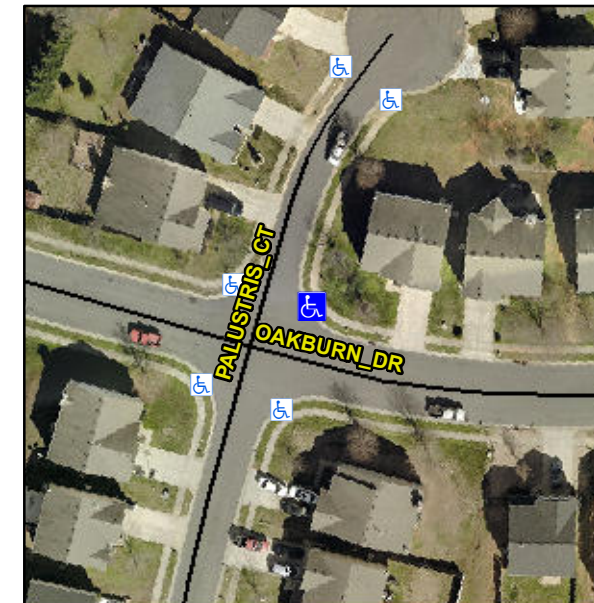
**Not Found, R304.5.1, R304.5.3**

Compliance	Description	Data	Compliance	Description	Data
N/A	Ramp Length (in)	48.0	Yes	Ramp Slope (%)	7.1
No	Ramp Width (in)	42.5	No	Ramp XSlope (%)	2.5
N/A	Flare Type LT	N/A	N/A	Flare Type RT	N/A
N/A	Flare Slope LT (%)	N/A	N/A	Flare Slope RT (%)	N/A
N/A	Flare Traversable LT?	N/A	N/A	Flare Traversable RT?	N/A
N/A	Landing Length (in)	N/A	N/A	DWS Provided?	N/A
N/A	Landing Width (in)	N/A	N/A	DWS Contrast?	N/A
N/A	Landing Slope (%)	N/A	N/A	DWS Length (in)	N/A
N/A	Landing X Slope (%)	N/A	N/A	DWS Full Width?	N/A
N/A	Landing Curb? (Y/N)	N/A	N/A	DWS Offset (in)	N/A
N/A	Shared Landing?	N/A			
N/A	Gutter Ponding?	N/A	N/A	Gutter Slope (%)	N/A
N/A	Gutter Lip Ht (in)	N/A	N/A	Gutter X Slope (%)	N/A
N/A	Painted X Walk1?	No	N/A	Painted X Walk2?	No
	X Walk 1 Direction	To NW		X Walk 2 Direction	To SW
N/A	X Walk 1 Width (in)	N/A	N/A	X Walk 2 Width (in)	N/A
	X Walk 1 Slope (%)	3.3		X Walk 2 Slope (%)	1.0
	X Walk 1 X Slope (%)	2.4		X Walk 2 X Slope (%)	3.4

N/A	Ramp inside XWalk1?	N/A	N/A	Ramp inside XWalk2?	N/A
	Road Slope (%)	2.2	N/A	Clear Space?	N/A
	Road X Slope (%)	3.6	N/A	Clear Space to XWalk (in)	N/A
N/A	Any Obstructions?	N/A	N/A	Storm Grate/Utility Hazard?	N/A
	Obstruction Type			Storm Grate/Utility Type	
		N/A			N/A
			Yes	Surface Condition? (G/P)	Good

**Remove & Replace Curb Ramp With Two New Directional Ramps or Equivalent.**

Total Cost: \$ 3200.00
