Access Compliance Report

Public Rights-of-Way

(Curb Ramps)

Intersection ID: 47277	Main Street: CANDLEWOOD RIDGE LN	Cross Street: CARRINGTON FOREST LN	Location: NE
ADA ID: EF55A70F882B	Ramp Type: Perp	Initial Pass/Fail: Fail	Overall Compliance: No
Codes/Mitigation Info/Possible Solution		Field Measurements/Component Compliance	
Severity Score: 12.5

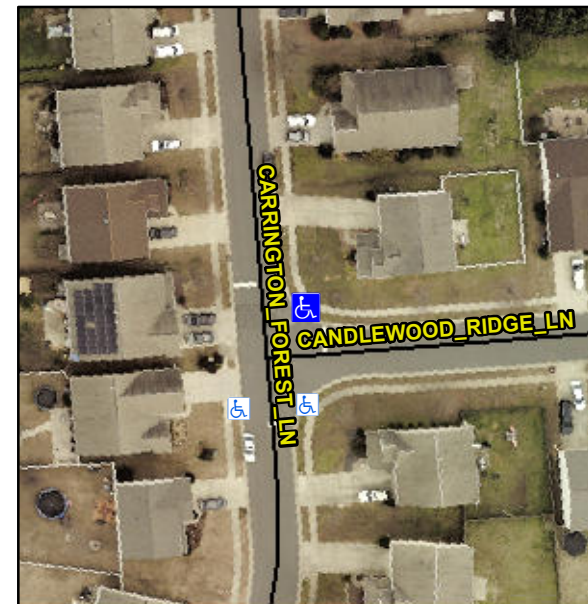
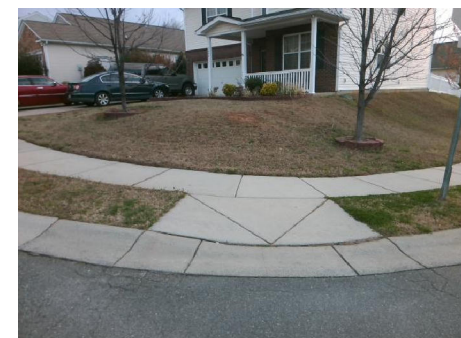
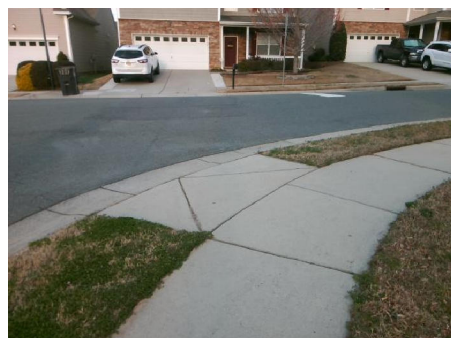
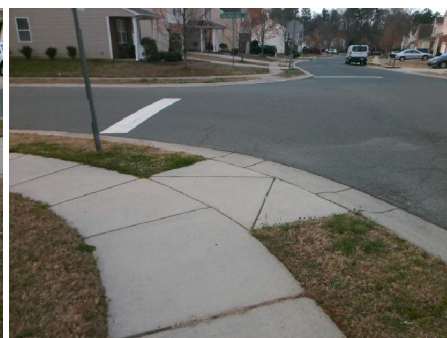
Not Found, R304.5.3

Compliance	Description	Data	Compliance	Description	Data
N/A	Ramp Length (in)	50.0	Yes	Ramp Slope (%)	8.1
Yes	Ramp Width (in)	54.0	No	Ramp XSlope (%)	5.8
N/A	Flare Type LT	N/A	N/A	Flare Type RT	N/A
N/A	Flare Slope LT (%)	N/A	N/A	Flare Slope RT (%)	N/A
N/A	Flare Traversable LT?	N/A	N/A	Flare Traversable RT?	N/A
N/A	Landing Length (in)	N/A	N/A	DWS Provided?	N/A
N/A	Landing Width (in)	N/A	N/A	DWS Contrast?	N/A
N/A	Landing Slope (%)	N/A	N/A	DWS Length (in)	N/A
N/A	Landing X Slope (%)	N/A	N/A	DWS Full Width?	N/A
N/A	Landing Curb? (Y/N)	N/A	N/A	DWS Offset (in)	N/A
N/A	Shared Landing?	N/A			
N/A	Gutter Ponding?	N/A	N/A	Gutter Slope (%)	N/A
N/A	Gutter Lip Ht (in)	N/A	N/A	Gutter X Slope (%)	N/A
N/A	Painted X Walk1?	No	N/A	Painted X Walk2?	N/A
	X Walk 1 Direction	To S		X Walk 2 Direction	N/A
N/A	X Walk 1 Width (in)	N/A	N/A	X Walk 2 Width (in)	N/A
	X Walk 1 Slope (%)	5.5		X Walk 2 Slope (%)	N/A
	X Walk 1 X Slope (%)	6.5		X Walk 2 X Slope (%)	N/A

N/A	Ramp inside XWalk1?	N/A	N/A	Ramp inside XWalk2?	N/A
	Road Slope (%)	3.1	N/A	Clear Space?	N/A
	Road X Slope (%)	3.2	N/A	Clear Space to XWalk (in)	N/A
N/A	Any Obstructions?	N/A	N/A	Storm Grate/Utility Hazard?	N/A
	Obstruction Type			Storm Grate/Utility Type	
		N/A			N/A
			Yes	Surface Condition? (G/P)	Good

Remove & Replace Entire Ramp.
