Access Compliance Report

(Curb Ramps)

Intersection ID: 12519	Main Street: E_6TH_ST	Cross Street: N_CALDWELL_ST	Location: N
ADA ID: EF55EE141442	Ramp Type: PerpDiag	Initial Pass/Fail: Fail	Overall Compliance: No
			Severity Score: 58.75

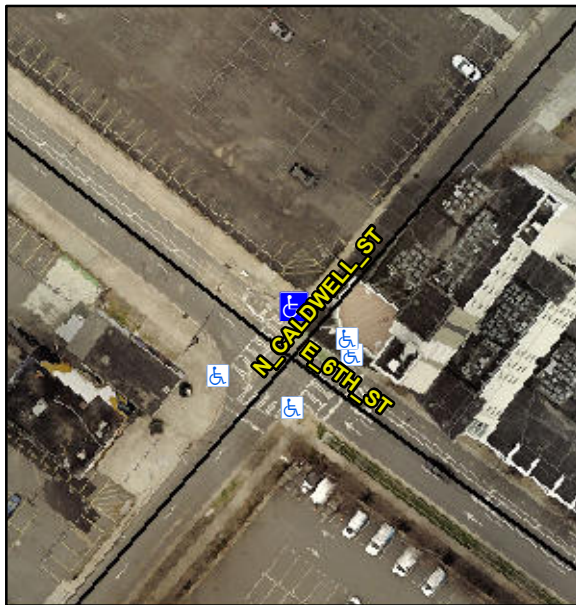
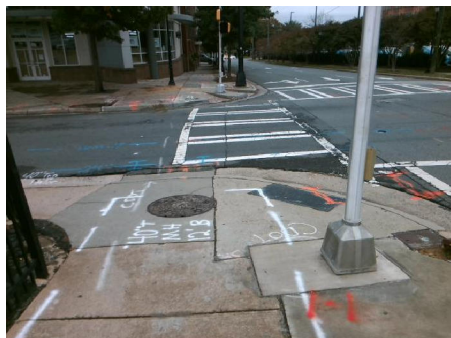
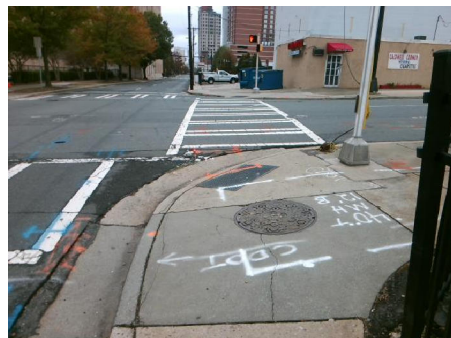
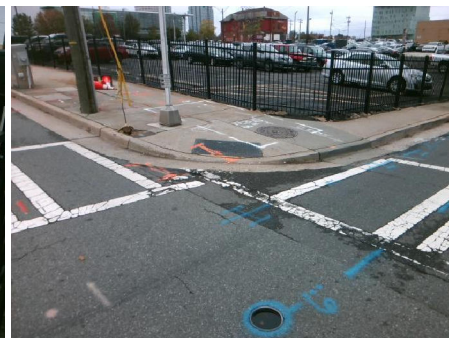
Not Found, R304.5.1, R304.2.2, R304.5.3

Compliance	Description	Data	Compliance	Description	Data
N/A	Ramp Length (in)	58.0	No	Ramp Slope (%)	14.1
No	Ramp Width (in)	41.0	No	Ramp XSlope (%)	9.5
N/A	Flare Type LT	N/A	N/A	Flare Type RT	N/A
N/A	Flare Slope LT (%)	N/A	N/A	Flare Slope RT (%)	N/A
N/A	Flare Traversable LT?	N/A	N/A	Flare Traversable RT?	N/A
N/A	Landing Length (in)	N/A	N/A	DWS Provided?	N/A
N/A	Landing Width (in)	N/A	N/A	DWS Contrast?	N/A
N/A	Landing Slope (%)	N/A	N/A	DWS Length (in)	N/A
N/A	Landing X Slope (%)	N/A	N/A	DWS Full Width?	N/A
N/A	Landing Curb? (Y/N)	N/A	N/A	DWS Offset (in)	N/A
N/A	Shared Landing?	N/A			
N/A	Gutter Ponding?	N/A	N/A	Gutter Slope (%)	N/A
N/A	Gutter Lip Ht (in)	0.5	N/A	Gutter X Slope (%)	N/A
N/A	Painted X Walk1?	Yes	N/A	Painted X Walk2?	Yes
	X Walk 1 Direction	To SW		X Walk 2 Direction	To SE
N/A	X Walk 1 Width (in)	110.0	N/A	X Walk 2 Width (in)	109.0
	X Walk 1 Slope (%)	2.9		X Walk 2 Slope (%)	2.6
	X Walk 1 X Slope (%)	3.0		X Walk 2 X Slope (%)	5.2

N/A	Ramp inside XWalk1?	Yes	N/A	Ramp inside XWalk2?	Yes
	Road Slope (%)	7.7	N/A	Clear Space?	N/A
	Road X Slope (%)	4.8	N/A	Clear Space to XWalk (in)	N/A
N/A	Any Obstructions?	N/A	N/A	Storm Grate/Utility Hazard?	N/A
	Obstruction Type			Storm Grate/Utility Type	
		N/A			N/A
			Yes	Surface Condition? (G/P)	Good

Remove & Replace Curb Ramp With Two New Directional Ramps or Equivalent.
