Access Compliance Report Public Rights-of-Way (Curb Ramps)

Intersection ID: 48953	Main Street: DAVID_JENNINGS_AV			Cross Street: GATESMILLS_AV					Location:	S
ADA ID: EF5AA93E319B	Ramp Type: Perp			Initial Pass/Fail: Fail Overall Compliance: N				ce: N	o Severity Score:	21.25
Codes/Mitigation Info/Possible Solution				Field Measurements/Component Compliance						
		Possible Solutions:							Compliance Description Data	
0000		Remove & Replace Entire R				Ramp Length (in)	46.5	No	Ramp Slope (%)	9.5
		Remove & Replace	Entire Ramp.	No		Ramp Width (in)	40.5	Yes	Ramp XSlope (%)	0.6
				NC N//		Flare Type LT	47.3 N/A	N/A	Flare Type RT	0.0 N/A
		4		N//			N/A	N/A		N/A N/A
						Flare Slope LT (%)			Flare Slope RT (%)	
Davis S O				N//		lare Traversable LT?	N/A	N/A	Flare Traversable RT?	N/A
INNES -				N//		anding Length (in)	N/A	N/A	DWS Provided?	N/A
A A A		Surveyor Notes:		N/.		anding Width (in)	N/A	N/A	DWS Contrast?	N/A

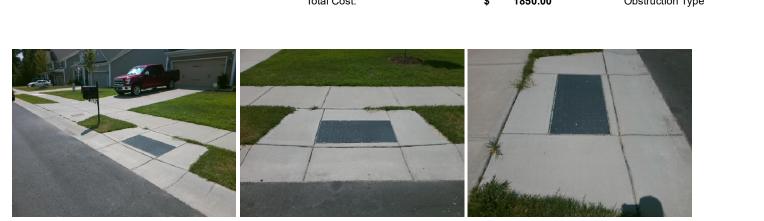
E.		N/A		N/2		anding Slope (%)	N/A	N/A	DWS Length (in)	N/A
	The second second			N/2	A La	anding X Slope (%)	N/A	N/A	DWS Full Width?	N/A
				N/2	A La	anding Curb? (Y/N)	N/A	N/A	DWS Offset (in)	N/A
	1 . S M .			N/2	A S	shared Landing?	N/A			
A In I	TT UP	PROW/ADA:		N/2	A G	Sutter Ponding?	N/A	N/A	Gutter Slope (%)	N/A
. Maria i Jana	1 1 1 2	Not Found, R304.	5.1, R304.2.2	N//	A G	Gutter Lip Ht (in)	N/A	N/A	Gutter X Slope (%)	N/A
alter the second	,		N/2	A Pa	ainted X Walk1?	No	N/A	Painted X Walk2?	N/A

- Alter There					Х	Walk 1 Direction	To NE		X Walk 2 Direction	N/A
				N/2	A X	Walk 1 Width (in)	N/A	N/A	X Walk 2 Width (in)	N/A
Street 1 Name	DAVID JENNINGS AV	-			Х	Walk 1 Slope (%)	0.1		X Walk 2 Slope (%)	N/A
Stop Condition-Street 2	None					Walk 1 X Slope (%)	1.1		X Walk 2 X Slope (%)	N/A
Street 2 Name	N/A			N//	A R	Ramp inside XWalk1?	N/A	N/A	Ramp inside XWalk2?	N/A
Stop Condition-Street 1	N/A					Road Slope (%)	N/A	N/A	Clear Space?	N/A
					R	Road X Slope (%)	N/A	N/A	Clear Space to XWalk (in)	N/A
				N/		Any Obstructions?	N/A	N/A	Storm Grate/Utility Hazard?	N/A
		Total Cost:	\$ 1	850.00		Dbstruction Type			Storm Grate/Utility Type	
			÷ '		Ũ		N/A			N/A
							17/4			11/2
