# Access Compliance Report

## Public Rights-of-Way (Curb Ramps)

Intersection ID: 5026	Main Street: PASSOUR_RIDGE_LN	Cross Street: WILKINS_TERRACE_DR	Location: SE
ADA ID: EF5DB9D9B8B6	Ramp Type: Perp	Initial Pass/Fail: Fail	Overall Compliance: No
		Severity Score: 22.5

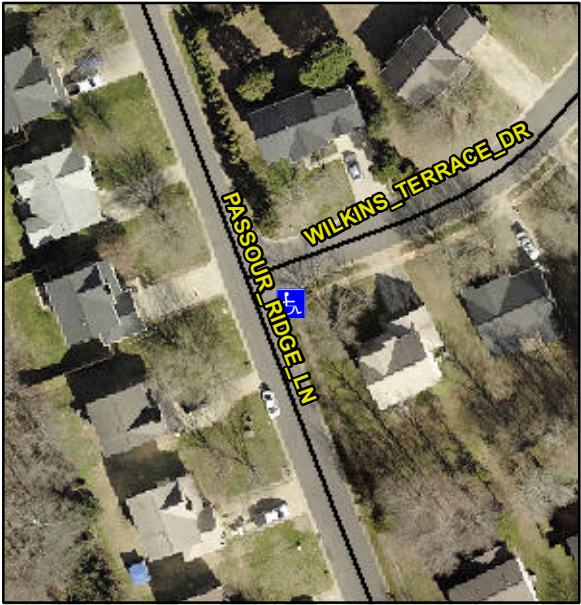
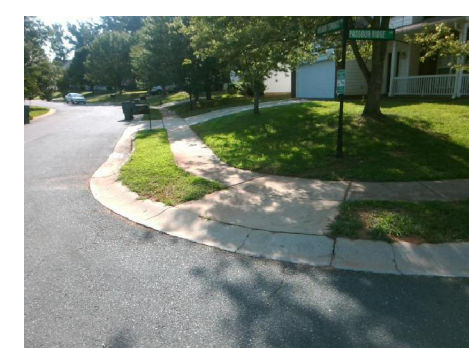
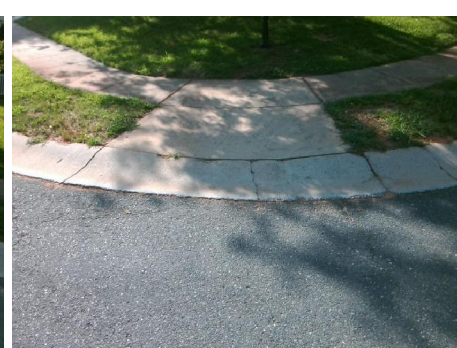
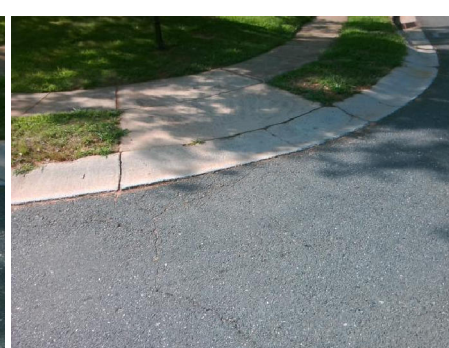
Possible Solutions:		<b>Compliance</b>	<b>Description</b>	<b>Data</b>
	<b>Remove &amp; Replace Entire Ramp.</b>		<b>No</b>	Ramp Length (in)	49.0
			<b>No</b>	Ramp Width (in)	45.0
			<b>N/A</b>	Flare Type LT	N/A
			<b>N/A</b>	Flare Slope LT (%)	N/A
			<b>N/A</b>	Flare Traversable LT?	N/A
			<b>N/A</b>	Landing Length (in)	N/A
			<b>N/A</b>	Landing Width (in)	N/A
			<b>N/A</b>	Landing Slope (%)	N/A
			<b>N/A</b>	Landing X Slope (%)	N/A
<p>Surveyor Notes:</p> <p><b>N/A</b></p> <p>PROW/ADA:</p> <p><b>Not Found, R304.5.1, R304.2.2, R304.5.3</b></p>			<b>N/A</b>	Flare Type RT	N/A
			<b>N/A</b>	Flare Slope RT (%)	N/A
			<b>N/A</b>	Flare Traversable RT?	N/A
			<b>N/A</b>	DWS Provided?	N/A
			<b>N/A</b>	DWS Contrast?	N/A
			<b>N/A</b>	DWS Length (in)	N/A
			<b>N/A</b>	DWS Full Width?	N/A
			<b>N/A</b>	DWS Offset (in)	N/A
			<b>N/A</b>	Shared Landing?	N/A

<b>N/A</b>	Gutter Ponding?	N/A
			<b>N/A</b>	Gutter Lip Ht (in)	N/A
			<b>N/A</b>	Painted X Walk1?	No
				X Walk 1 Direction	To N
			<b>N/A</b>	X Walk 1 Width (in)	N/A
				X Walk 1 Slope (%)	0.4
				X Walk 1 X Slope (%)	3.4
			<b>N/A</b>	Ramp inside XWalk1?	N/A
			<b>N/A</b>	Road Slope (%)	N/A
			<b>N/A</b>	Road X Slope (%)	N/A
			<b>N/A</b>	Any Obstructions?	N/A
Total Cost:		\$ 1850.00		Obstruction Type	
			<b>N/A</b>		
			<b>N/A</b>	Storm Grate/Utility Hazard?	N/A
				Storm Grate/Utility Type	
			<b>N/A</b>		N/A
			<b>Yes</b>	Surface Condition? (G/P)	Good
