Access Compliance Report

Public Rights-of-Way

(Curb Ramps)

Intersection ID: 7027	Main Street: TALUS_TRACE_LN	Cross Street: BEGONIA_DR	Location:	N
ADA ID: EF7AF534FC4E	Ramp Type: PerpDiag	Initial Pass/Fail: Fail	Overall Compliance: No	Severity Score: 21.25

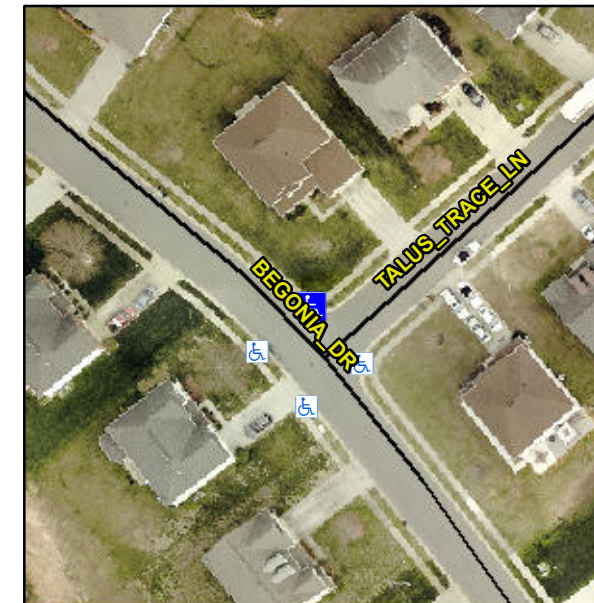
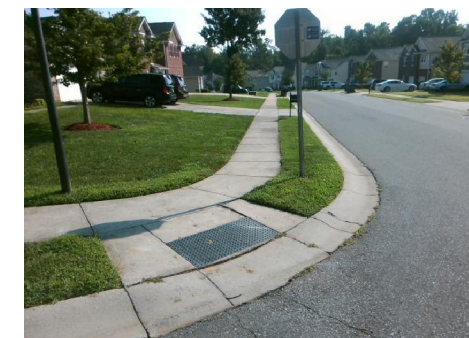
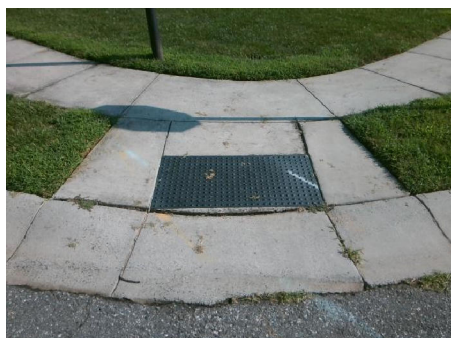
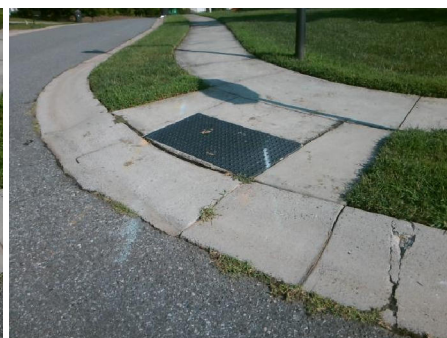
Not Found, R304.5.1, R304.5.3

Compliance	Description	Data	Compliance	Description	Data
N/A	Ramp Length (in)	49.0	Yes	Ramp Slope (%)	6.7
No	Ramp Width (in)	47.5	No	Ramp XSlope (%)	6.6
N/A	Flare Type LT	N/A	N/A	Flare Type RT	N/A
N/A	Flare Slope LT (%)	N/A	N/A	Flare Slope RT (%)	N/A
N/A	Flare Traversable LT?	N/A	N/A	Flare Traversable RT?	N/A
N/A	Landing Length (in)	N/A	N/A	DWS Provided?	N/A
N/A	Landing Width (in)	N/A	N/A	DWS Contrast?	N/A
N/A	Landing Slope (%)	N/A	N/A	DWS Length (in)	N/A
N/A	Landing X Slope (%)	N/A	N/A	DWS Full Width?	N/A
N/A	Landing Curb? (Y/N)	N/A	N/A	DWS Offset (in)	N/A
N/A	Shared Landing?	N/A			
N/A	Gutter Ponding?	N/A	N/A	Gutter Slope (%)	N/A
N/A	Gutter Lip Ht (in)	N/A	N/A	Gutter X Slope (%)	N/A
N/A	Painted X Walk1?	No	N/A	Painted X Walk2?	No
	X Walk 1 Direction	To SW		X Walk 2 Direction	To SE
N/A	X Walk 1 Width (in)	N/A	N/A	X Walk 2 Width (in)	N/A
	X Walk 1 Slope (%)	3.5		X Walk 2 Slope (%)	1.5
	X Walk 1 X Slope (%)	1.9		X Walk 2 X Slope (%)	4.3

N/A	Ramp inside XWalk1?	N/A	N/A	Ramp inside XWalk2?	N/A
	Road Slope (%)	4.7	N/A	Clear Space?	N/A
	Road X Slope (%)	3.2	N/A	Clear Space to XWalk (in)	N/A
N/A	Any Obstructions?	N/A	N/A	Storm Grate/Utility Hazard?	N/A
	Obstruction Type			Storm Grate/Utility Type	
		N/A			N/A
			Yes	Surface Condition? (G/P)	Good

Remove & Replace Curb Ramp With Two New Directional Ramps or Equivalent.
