Access Compliance Report

Public Rights-of-Way

(Curb Ramps)

| Intersection ID: 13600 | Main Street: 3RD-4TH_CONNECTOR_ST | Cross Street: E_4TH_ST | Location: | N |

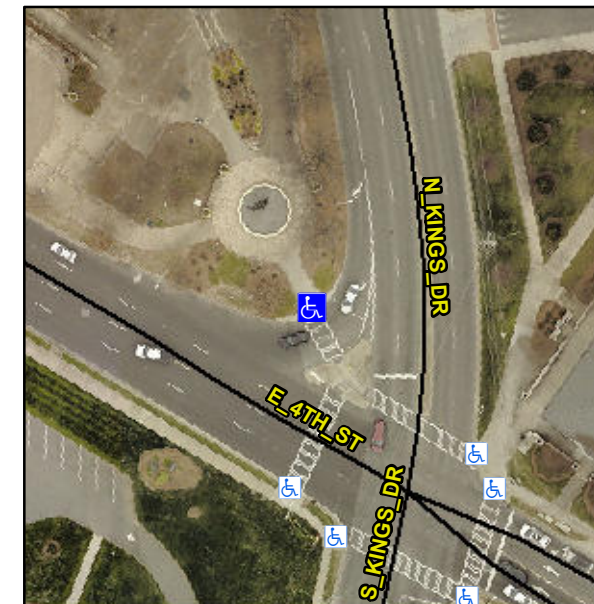
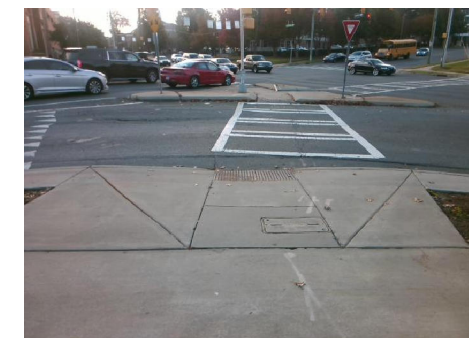
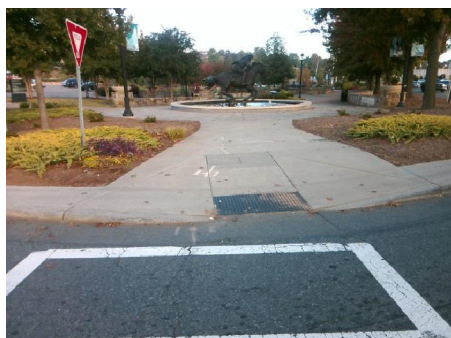
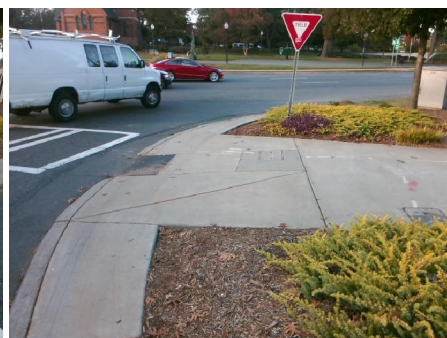
| ADA ID: EF80BB9F486E | Ramp Type: Perp | Initial Pass/Fail: Fail | Overall Compliance: No | Severity Score: 12.5 |

R304.2.2

| Compliance | Description | Data | Compliance | Description | Data |
|---|---|---|---|---|---|
| N/A | Ramp Length (in) | 72.0 | No | Ramp Slope (%) | 8.6 |

Remove & Replace Entire Ramp.
