Access Compliance Report

Public Rights-of-Way

(Curb Ramps)

| Intersection ID: 12770 | Main Street: HICKORY GROVE RD | Cross Street: N_SHARON AMITY RD | Location: S |

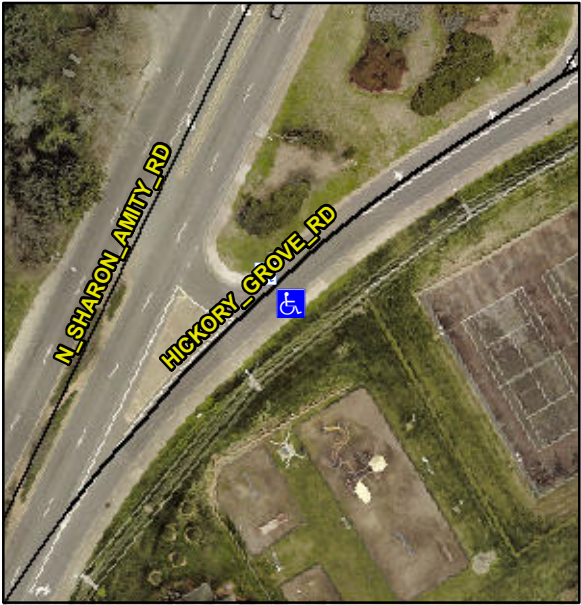
| ADA ID: EF879E89EFBB | Ramp Type: Perp | Initial Pass/Fail: Fail | Overall Compliance: No |
| Severity Score: 10 | | | |

| | | No | Ramp Width (in) | 40.0 | Yes | Ramp XSlope (%) | 3.4 |
| <p>Surveyor Notes:</p> <p>N/A</p> <p>PROW/ADA:</p> <p>Not Found, R304.5.1</p> | | | Road Slope (%) | N/A | N/A | Clear Space? | N/A |

| | Remove & Replace Entire Ramp. | N/A | Ramp Length (in) | 60.0 | Yes | Ramp Slope (%) | 7.0 |
