Access Compliance Report

Public Rights-of-Way

(Curb Ramps)

Intersection ID: 24824	Main Street: CARMEL_HILLS_DR	Cross Street: CARMEL_RD	Location: NE
ADA ID: EFA3F835CEFA	Ramp Type: PerpDiag	Initial Pass/Fail: Fail	Overall Compliance: No
Severity Score: 21.25			
Codes/Mitigation Info/Possible Solution		Field Measurements/Component Compliance

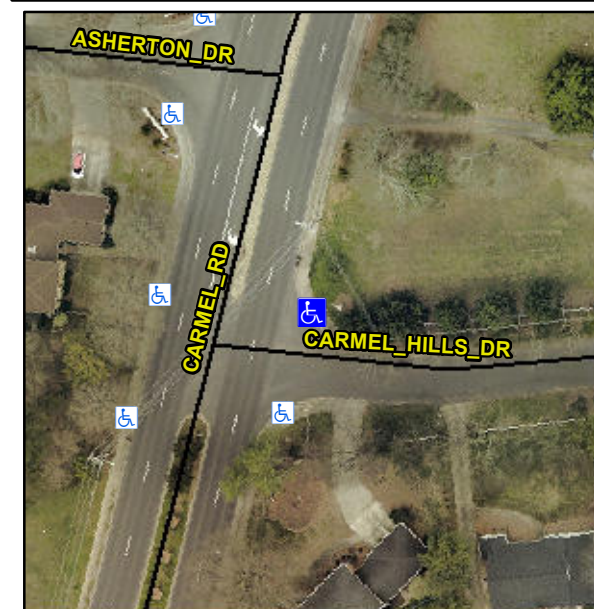
Not Found, R304.5.1, R304.5.3

Compliance	Description	Data	Compliance	Description	Data
N/A	Ramp Length (in)	60.0	Yes	Ramp Slope (%)	5.9
No	Ramp Width (in)	43.0	No	Ramp XSlope (%)	5.1
N/A	Flare Type LT	N/A	N/A	Flare Type RT	N/A
N/A	Flare Slope LT (%)	N/A	N/A	Flare Slope RT (%)	N/A
N/A	Flare Traversable LT?	N/A	N/A	Flare Traversable RT?	N/A
N/A	Landing Length (in)	N/A	N/A	DWS Provided?	N/A
N/A	Landing Width (in)	N/A	N/A	DWS Contrast?	N/A
N/A	Landing Slope (%)	N/A	N/A	DWS Length (in)	N/A
N/A	Landing X Slope (%)	N/A	N/A	DWS Full Width?	N/A
N/A	Landing Curb? (Y/N)	N/A	N/A	DWS Offset (in)	N/A
N/A	Shared Landing?	N/A			
N/A	Gutter Ponding?	N/A	N/A	Gutter Slope (%)	N/A
N/A	Gutter Lip Ht (in)	N/A	N/A	Gutter X Slope (%)	N/A
N/A	Painted X Walk1?	No	N/A	Painted X Walk2?	No
	X Walk 1 Direction	To NW		X Walk 2 Direction	To SW
N/A	X Walk 1 Width (in)	N/A	N/A	X Walk 2 Width (in)	N/A
	X Walk 1 Slope (%)	4.8		X Walk 2 Slope (%)	0.4
	X Walk 1 X Slope (%)	0.7		X Walk 2 X Slope (%)	3.5

N/A	Ramp inside XWalk1?	N/A	N/A	Ramp inside XWalk2?	N/A
	Road Slope (%)	3.8	N/A	Clear Space?	N/A
	Road X Slope (%)	3.0	N/A	Clear Space to XWalk (in)	N/A
N/A	Any Obstructions?	N/A	N/A	Storm Grate/Utility Hazard?	N/A
	Obstruction Type			Storm Grate/Utility Type	
		N/A			N/A
		Yes		Surface Condition? (G/P)	Good

Remove & Replace Curb Ramp With Two New Directional Ramps or Equivalent.
