## Access Compliance Report Public Rights-of-Way (Curb Ramps)

Intersection ID: 11707 Main Street: N\_GRAHAM\_ST Cross Street: W\_6TH\_ST Location: N

ADA ID: EFAD2BD1118B Ramp Type: Perp Initial Pass/Fail: Fail Overall Compliance: No Severity Score: 13.75

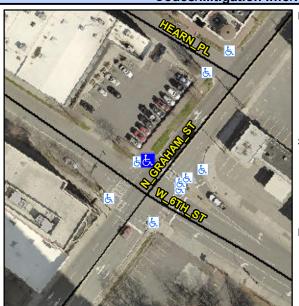
Not Found, R304.2.2, R304.5.3

Fleid Measurements/Component Compilance					
Compliance Description			Compliance Description		Data
N/A	Ramp Length (in)	84.0	No	Ramp Slope (%)	11.1
Yes	Ramp Width (in)	49.0	No	Ramp XSlope (%)	2.8
N/A	Flare Type LT	N/A	N/A	Flare Type RT	N/A
N/A	Flare Slope LT (%)	N/A	N/A	Flare Slope RT (%)	N/A
N/A	Flare Traversable LT?	N/A	N/A	Flare Traversable RT?	N/A
N/A	Landing Length (in)	N/A	N/A	DWS Provided?	N/A
N/A	Landing Width (in)	N/A	N/A	DWS Contrast?	N/A
N/A	Landing Slope (%)	N/A	N/A	DWS Length (in)	N/A
N/A	Landing X Slope (%)	N/A	N/A	DWS Full Width?	N/A
N/A	Landing Curb? (Y/N)	N/A	N/A	DWS Offset (in)	N/A
N/A	Shared Landing?	N/A			
N/A	Gutter Ponding?	N/A	N/A	Gutter Slope (%)	N/A
N/A	Gutter Lip Ht (in)	N/A	N/A	Gutter X Slope (%)	N/A
N/A	Painted X Walk1?	Yes	N/A	Painted X Walk2?	N/A
	X Walk 1 Direction	To SE		X Walk 2 Direction	N/A
N/A	X Walk 1 Width (in)	109.0	N/A	X Walk 2 Width (in)	N/A
	X Walk 1 Slope (%)	4.3		X Walk 2 Slope (%)	N/A

X Walk 1 X Slope (%)	1.8		X Walk 2 X Slope (%)	N/A
N/A	Ramp inside XWalk1?	Yes	N/A	Ramp inside XWalk2?	N/A
	Road Slope (%)	N/A	N/A	Clear Space?	N/A
	Road X Slope (%)	N/A	N/A	Clear Space to XWalk (in)	N/A
N/A	Any Obstructions?	N/A	N/A	Storm Grate/Utility Hazard?	N/A
	Obstruction Type		l	Storm Grate/Utility Type	
		N/A			N/A
			Yes	Surface Condition? (G/P)	Good

Remove & Replace Entire Ramp.

Total Cost: \$ 1850.00
