# Access Compliance Report

## Public Rights-of-Way

### (Curb Ramps)

| Intersection ID: 12342 | Main Street: E_8TH_ST | Cross Street: N_CALDWELL_ST | Location: S |

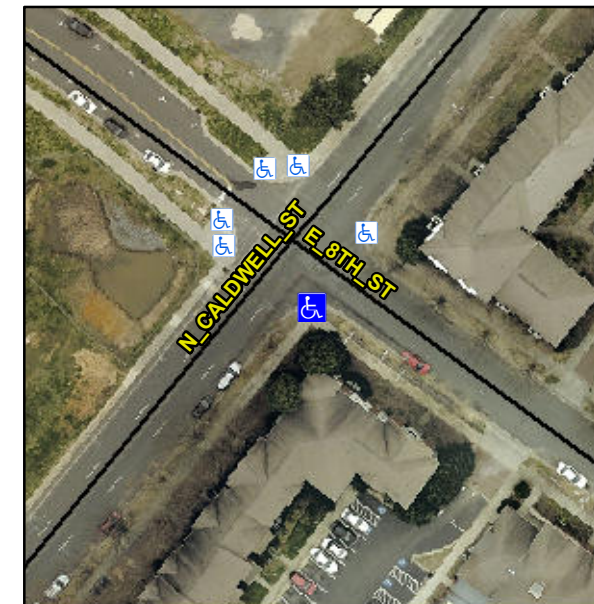
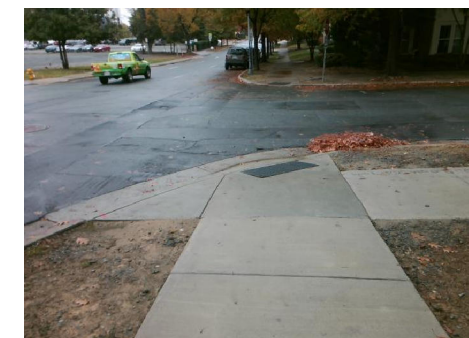
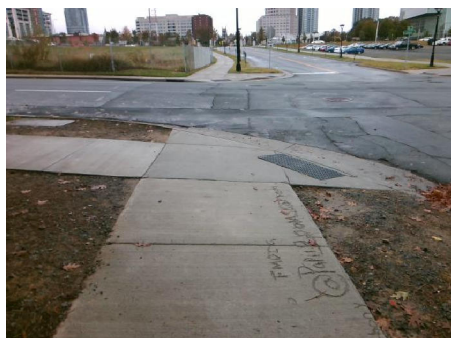
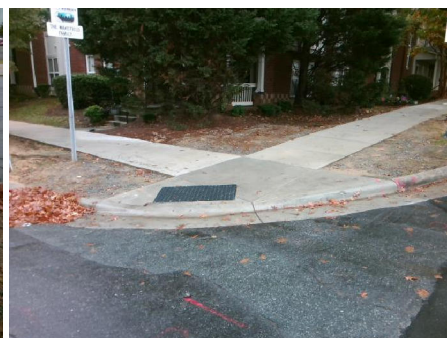
**Not Found, R304.2.2, R304.5.3**

| Compliance | Description | Data | Compliance | Description | Data |
|---|---|---|---|---|---|
| N/A | Ramp Length (in) | 41.0 | No | Ramp Slope (%) | 11.4 |
| Yes | Ramp Width (in) | 64.0 | No | Ramp XSlope (%) | 7.2 |

**Remove & Replace Curb Ramp With Two New Directional Ramps or Equivalent.**

Total Cost: \$ 3200.00
