# Access Compliance Report

## Public Rights-of-Way

### (Curb Ramps)

Intersection ID: 16599	Main Street: AMITY_PL	Cross Street: REDDMAN_RD	Location: SW
ADA ID: EFDB5C85A9D8	Ramp Type: BlendTrans2	Initial Pass/Fail: Fail	Overall Compliance: No
		Severity Score: 8.75

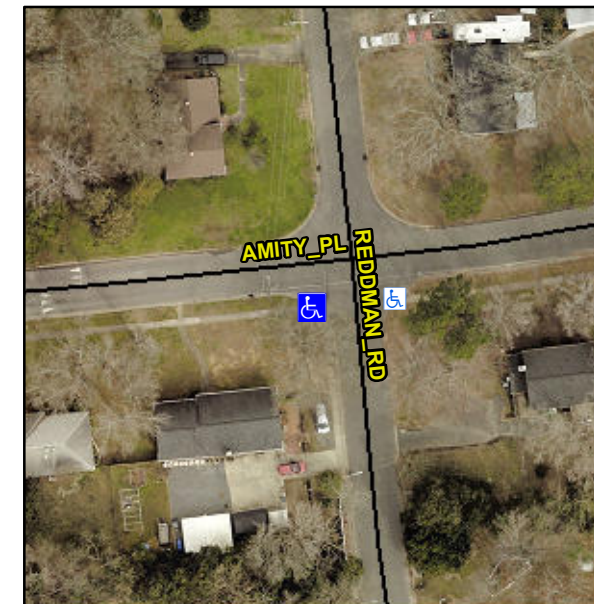
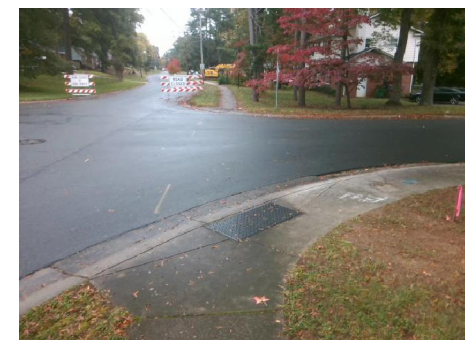
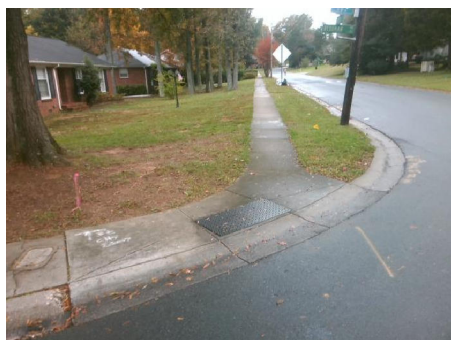
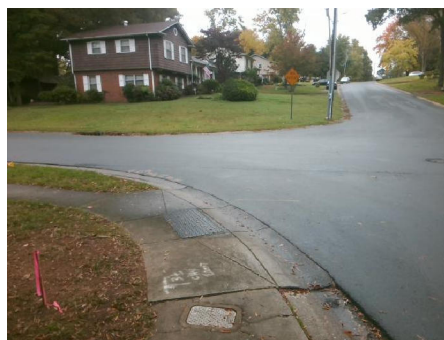
**Not Found, R304.5.1**

Compliance	Description	Data	Compliance	Description	Data
N/A	Ramp Length (in)	49.0	Yes	BlendTrans Slope (%)	1.9
No	Ramp Width (in)	39.0	Yes	BlendTrans XSlope (%)	1.1
N/A	Flare Type LT	N/A	N/A	Flare Type RT	N/A
N/A	Flare Slope LT (%)	N/A	N/A	Flare Slope RT (%)	N/A
N/A	Flare Traversable LT?	N/A	N/A	Flare Traversable RT?	N/A
N/A	Landing Length (in)	N/A	N/A	DWS Provided?	N/A
N/A	Landing Width (in)	N/A	N/A	DWS Contrast?	N/A
N/A	Landing Slope (%)	N/A	N/A	DWS Length (in)	N/A
N/A	Landing X Slope (%)	N/A	N/A	DWS Full Width?	N/A
N/A	Landing Curb? (Y/N)	N/A	N/A	DWS Offset (in)	N/A
N/A	Shared Landing?	N/A			
N/A	Gutter Ponding?	N/A	N/A	Gutter Slope (%)	N/A
N/A	Gutter Lip Ht (in)	N/A	N/A	Gutter X Slope (%)	N/A
N/A	Painted X Walk1?	No	N/A	Painted X Walk2?	No
	X Walk 1 Direction	To E		X Walk 2 Direction	To N
	X Walk 1 Width (in)	N/A		X Walk 2 Width (in)	N/A
	X Walk 1 Slope (%)	2.2		X Walk 2 Slope (%)	5.1
	X Walk 1 X Slope (%)	3.8		X Walk 2 X Slope (%)	1.6

N/A	Ramp inside XWalk1?	N/A	N/A	Ramp inside XWalk2?	N/A
	Road Slope (%)	1.2		Clear Space?	N/A
	Road X Slope (%)	5.5	N/A	Clear Space to XWalk (in)	N/A
N/A	Any Obstructions?	N/A	N/A	Storm Grate/Utility Hazard?	N/A
	Obstruction Type			Storm Grate/Utility Type	
		N/A			N/A
			Yes	Surface Condition? (G/P)	Good
			No	Curb Slope (%)	15.1

**Remove & Replace Curb Ramp With Two New Directional Ramps or Equivalent.**

Total Cost: \$ 3200.00
