# Access Compliance Report

## Public Rights-of-Way

### (Curb Ramps)

Intersection ID: 24674	Main Street: CARMEL_RD	Cross Street: CARMEL_VISTA_LN	Location: E
ADA ID: EFE3C0028B5B	Ramp Type: Perp	Initial Pass/Fail: Fail	Overall Compliance: No
Severity Score: 33.75			
Codes/Mitigation Info/Possible Solution		Field Measurements/Component Compliance

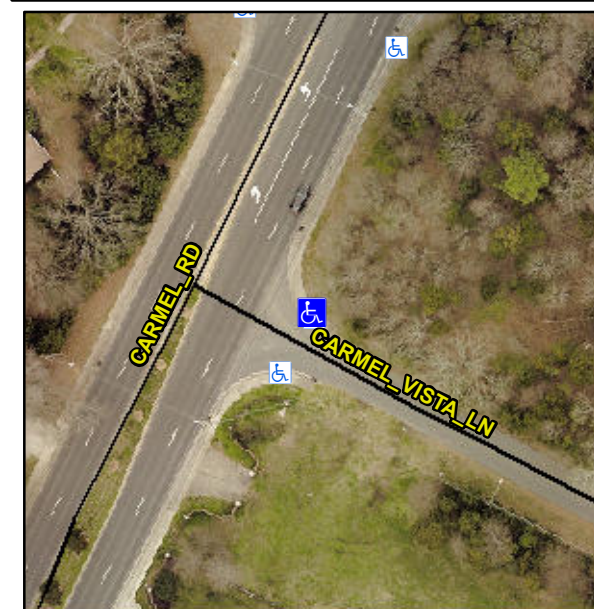
**Not Found, R304.5.1, R304.2.2**

Compliance	Description	Data	Compliance	Description	Data
N/A	Ramp Length (in)	60.0	No	Ramp Slope (%)	14.2
No	Ramp Width (in)	46.0	Yes	Ramp XSlope (%)	1.1
N/A	Flare Type LT	N/A	N/A	Flare Type RT	N/A
N/A	Flare Slope LT (%)	N/A	N/A	Flare Slope RT (%)	N/A
N/A	Flare Traversable LT?	N/A	N/A	Flare Traversable RT?	N/A
N/A	Landing Length (in)	N/A	N/A	DWS Provided?	N/A
N/A	Landing Width (in)	N/A	N/A	DWS Contrast?	N/A
N/A	Landing Slope (%)	N/A	N/A	DWS Length (in)	N/A
N/A	Landing X Slope (%)	N/A	N/A	DWS Full Width?	N/A
N/A	Landing Curb? (Y/N)	N/A	N/A	DWS Offset (in)	N/A
N/A	Shared Landing?	N/A			
N/A	Gutter Ponding?	N/A	N/A	Gutter Slope (%)	N/A
N/A	Gutter Lip Ht (in)	N/A	N/A	Gutter X Slope (%)	N/A
N/A	Painted X Walk1?	No	N/A	Painted X Walk2?	N/A
	X Walk 1 Direction	To SW		X Walk 2 Direction	N/A
N/A	X Walk 1 Width (in)	N/A	N/A	X Walk 2 Width (in)	N/A
	X Walk 1 Slope (%)	0.2		X Walk 2 Slope (%)	N/A
	X Walk 1 X Slope (%)	0.6		X Walk 2 X Slope (%)	N/A

N/A	Ramp inside XWalk1?	N/A	N/A	Ramp inside XWalk2?	N/A
	Road Slope (%)	N/A	N/A	Clear Space?	N/A
	Road X Slope (%)	N/A	N/A	Clear Space to XWalk (in)	N/A
N/A	Any Obstructions?	N/A	N/A	Storm Grate/Utility Hazard?	N/A
	Obstruction Type			Storm Grate/Utility Type	
		N/A			N/A
		Yes		Surface Condition? (G/P)	Good

**Remove & Replace Entire Ramp.**

Total Cost: \$ 1850.00
