# Access Compliance Report

## Public Rights-of-Way

### (Curb Ramps)

Intersection ID: 11824	Main Street: W_8TH_ST	Cross Street: N_CHURCH_ST	Location: S
ADA ID: EFE6B6000394	Ramp Type: PerpDiag	Initial Pass/Fail: Fail	Overall Compliance: No
Severity Score: 1.25			
Codes/Mitigation Info/Possible Solution		Field Measurements/Component Compliance

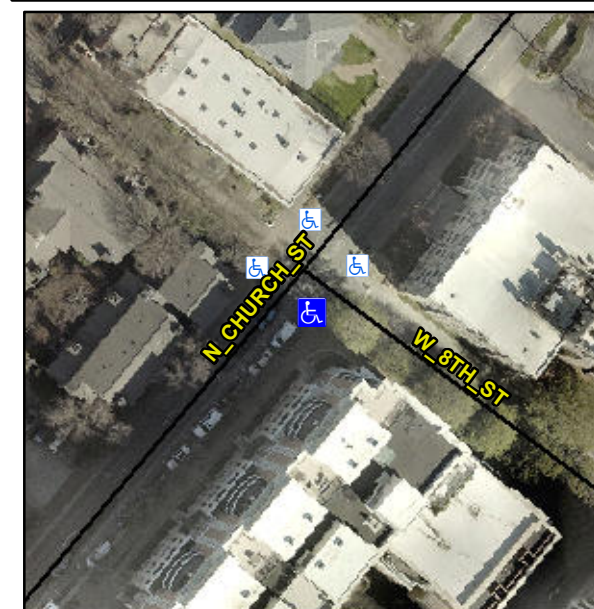
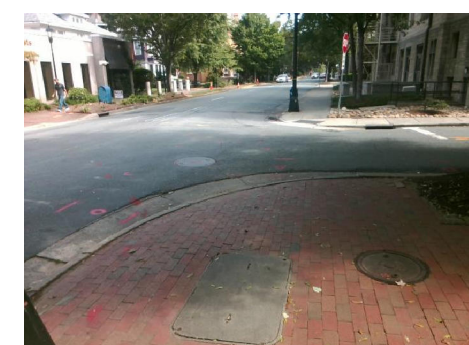
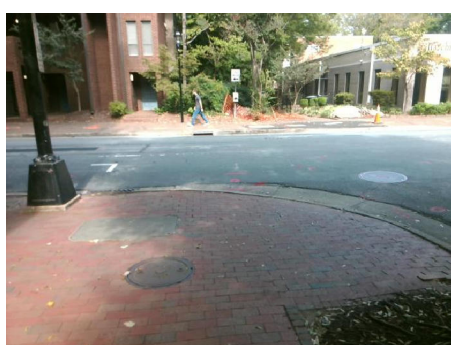
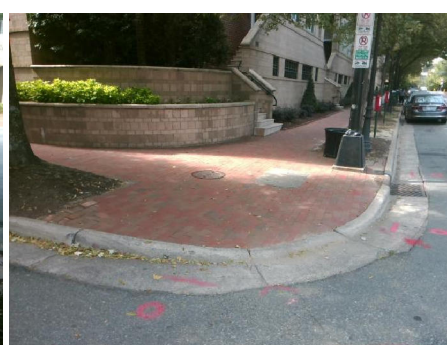
Compliance	Description	Data	Compliance	Description	Data
N/A	Ramp Length (in)	52.0	Yes	Ramp Slope (%)	5.7
Yes	Ramp Width (in)	48.0	No	Ramp XSlope (%)	3.1
N/A	Flare Type LT	N/A	N/A	Flare Type RT	N/A
N/A	Flare Slope LT (%)	N/A	N/A	Flare Slope RT (%)	N/A
N/A	Flare Traversable LT?	N/A	N/A	Flare Traversable RT?	N/A
N/A	Landing Length (in)	N/A	N/A	DWS Provided?	N/A
N/A	Landing Width (in)	N/A	N/A	DWS Contrast?	N/A
N/A	Landing Slope (%)	N/A	N/A	DWS Length (in)	N/A
N/A	Landing X Slope (%)	N/A	N/A	DWS Full Width?	N/A
N/A	Landing Curb? (Y/N)	N/A	N/A	DWS Offset (in)	N/A
N/A	Shared Landing?	N/A			
N/A	Gutter Ponding?	N/A	N/A	Gutter Slope (%)	N/A
N/A	Gutter Lip Ht (in)	N/A	N/A	Gutter X Slope (%)	N/A
N/A	Painted X Walk1?	No	N/A	Painted X Walk2?	No
	X Walk 1 Direction	To NE		X Walk 2 Direction	To NW
N/A	X Walk 1 Width (in)	N/A	N/A	X Walk 2 Width (in)	N/A
	X Walk 1 Slope (%)	4.8		X Walk 2 Slope (%)	1.9
	X Walk 1 X Slope (%)	2.0		X Walk 2 X Slope (%)	1.2

N/A	Ramp inside XWalk1?	N/A	N/A	Ramp inside XWalk2?	N/A
	Road Slope (%)	2.4	N/A	Clear Space?	N/A
	Road X Slope (%)	4.4	N/A	Clear Space to XWalk (in)	N/A
N/A	Any Obstructions?	N/A	N/A	Storm Grate/Utility Hazard?	N/A
	Obstruction Type			Storm Grate/Utility Type	
		N/A			N/A
		Yes		Surface Condition? (G/P)	Good

**Remove & Replace Curb Ramp With Two New Directional Ramps or Equivalent.**

**Not Found, R304.5.3**
