Access Compliance Report

Public Rights-of-Way

(Curb Ramps)

Intersection ID: 42785	Main Street: CALDWELL_RD	Cross Street: OLD_STONE_CROSSING_DR	Location: N
ADA ID: EFECB1E38E67	Ramp Type: BlendTrans1	Initial Pass/Fail: Fail	Overall Compliance: No
Severity Score: 18.75			
Codes/Mitigation Info/Possible Solution		Field Measurements/Component Compliance

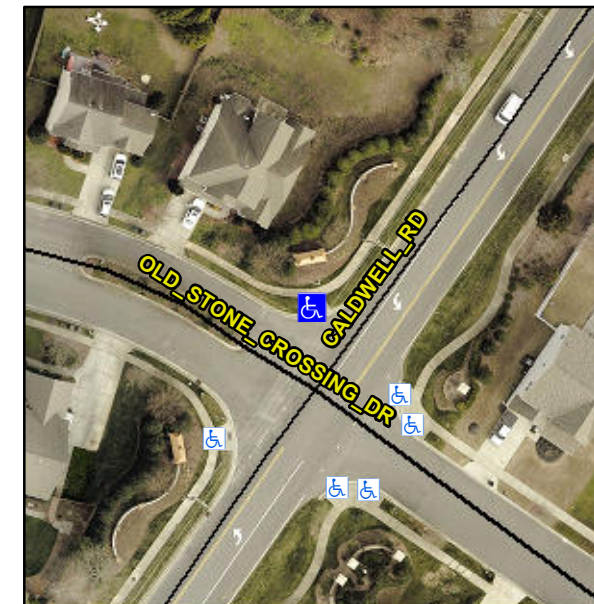
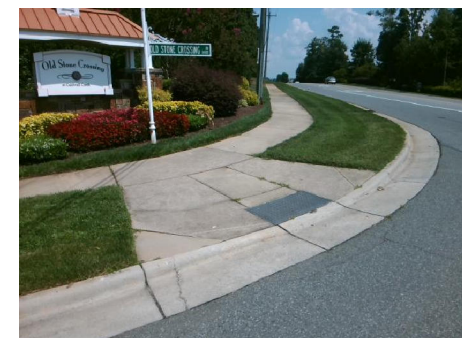
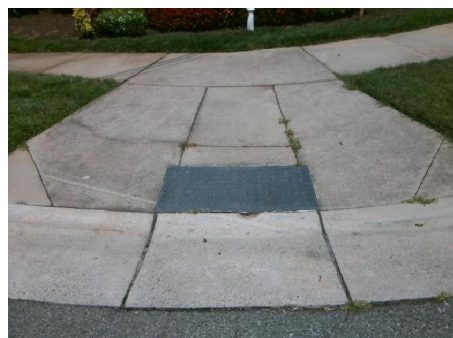
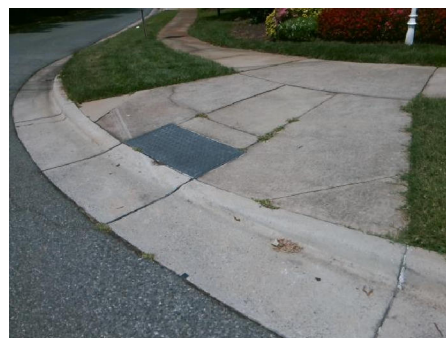
CURB LIP 1.0

Not Found, R304.5.1, R304.5.3

Compliance	Description	Data	Compliance	Description	Data
N/A	Ramp Length (in)	96.0	Yes	BlendTrans Slope (%)	4.9
No	Ramp Width (in)	34.0	No	BlendTrans XSlope (%)	2.9
N/A	Flare Type LT	N/A	N/A	Flare Type RT	N/A
N/A	Flare Slope LT (%)	N/A	N/A	Flare Slope RT (%)	N/A
N/A	Flare Traversable LT?	N/A	N/A	Flare Traversable RT?	N/A
N/A	Landing Length (in)	N/A	N/A	DWS Provided?	N/A
N/A	Landing Width (in)	N/A	N/A	DWS Contrast?	N/A
N/A	Landing Slope (%)	N/A	N/A	DWS Length (in)	N/A
N/A	Landing X Slope (%)	N/A	N/A	DWS Full Width?	N/A
N/A	Landing Curb? (Y/N)	N/A	N/A	DWS Offset (in)	N/A
N/A	Shared Landing?	N/A			
N/A	Gutter Ponding?	N/A	N/A	Gutter Slope (%)	N/A
N/A	Gutter Lip Ht (in)	N/A	N/A	Gutter X Slope (%)	N/A
N/A	Painted X Walk1?	No	N/A	Painted X Walk2?	No
	X Walk 1 Direction	To SW		X Walk 2 Direction	To SE
	X Walk 1 Width (in)	N/A		X Walk 2 Width (in)	N/A
	X Walk 1 Slope (%)	6.1		X Walk 2 Slope (%)	5.3
	X Walk 1 X Slope (%)	7.4		X Walk 2 X Slope (%)	0.3

N/A	Ramp inside XWalk1?	N/A	N/A	Ramp inside XWalk2?	N/A
	Road Slope (%)	5.5		Clear Space?	N/A
	Road X Slope (%)	9.7	N/A	Clear Space to XWalk (in)	N/A
N/A	Any Obstructions?	N/A	N/A	Storm Grate/Utility Hazard?	N/A
	Obstruction Type			Storm Grate/Utility Type	
		N/A			N/A
			Yes	Surface Condition? (G/P)	Good
			No	Curb Slope (%)	15.8

Remove & Replace Curb Ramp With Two New Directional Ramps or Equivalent.
