Access Compliance Report

Public Rights-of-Way

(Curb Ramps)

| Intersection ID: 10030654 | Main Street: LONG_CREEK_PY | Cross Street: N/A | Location: S |

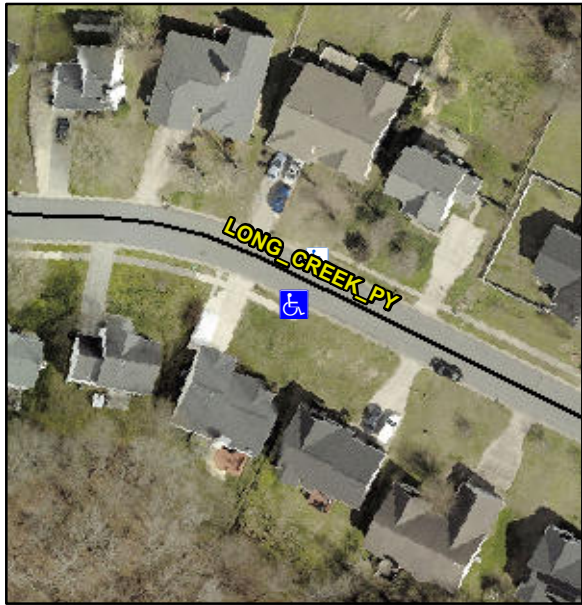
| ADA ID: EFF6D766C49D | Ramp Type: Perp | Initial Pass/Fail: Fail | Overall Compliance: No |

| | PROW/ADA: | | Not Found, R304.2.2, R304.5.3 | | |

| Compliance | Description | Data | Compliance | Description | Data |
|---|---|---|---|---|---|
| N/A | Ramp Length (in) | 48.0 | No | Ramp Slope (%) | 9.5 |
| Yes | Ramp Width (in) | 91.0 | No | Ramp XSlope (%) | 3.5 |

| | Possible Solutions: | | Remove & Replace Entire Ramp. | | |
| | Total Cost: | | \$ 1850.00 | | |
