Access Compliance Report Public Rights-of-Way (Curb Ramps)

Intersection ID: N/AMain Street:MELROSE_COTTAGE_DRCross Street:MARGARET_WALLACE_RDLocation:SWADA ID: EFFAA46E82ECRamp Type:PerpDiagInitial Pass/Fail:FailOverall Compliance:NoSeverity Score:10

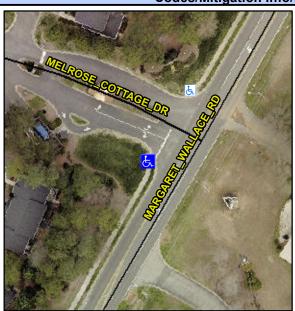
Not Found, R304.5.1, R304.5.3

Compliance Description		Data	Compliance Description		Data
N/A	Ramp Length (in)	48.0	Yes	Ramp Slope (%)	7.4
No	Ramp Width (in)	37.5	No	Ramp XSlope (%)	2.6
N/A	Flare Type LT	N/A	N/A	Flare Type RT	N/A
N/A	Flare Slope LT (%)	N/A	N/A	Flare Slope RT (%)	N/A
N/A	Flare Traversable LT?	N/A	N/A	Flare Traversable RT?	N/A
N/A	Landing Length (in)	N/A	N/A	DWS Provided?	N/A
N/A	Landing Width (in)	N/A	N/A	DWS Contrast?	N/A
N/A	Landing Slope (%)	N/A	N/A	DWS Length (in)	N/A
N/A	Landing X Slope (%)	N/A	N/A	DWS Full Width?	N/A
N/A	Landing Curb? (Y/N)	N/A	N/A	DWS Offset (in)	N/A
N/A	Shared Landing?	N/A			
N/A	Gutter Ponding?	N/A	N/A	Gutter Slope (%)	N/A
N/A	Gutter Lip Ht (in)	N/A	N/A	Gutter X Slope (%)	N/A
N/A	Painted X Walk1?	No	N/A	Painted X Walk2?	No
	X Walk 1 Direction	To SE		X Walk 2 Direction	To NE
N/A	X Walk 1 Width (in)	N/A	N/A	X Walk 2 Width (in)	N/A
	X Walk 1 Slope (%)	4.6		X Walk 2 Slope (%)	1.0
	X Walk 1 X Slope (%)	1.0		X Walk 2 X Slope (%)	2.9

N/A	Ramp inside XWalk1?	N/A	N/A	Ramp inside XWalk2?	N/A
	Road Slope (%)	0.6	N/A	Clear Space?	N/A
	Road X Slope (%)	4.0	N/A	Clear Space to XWalk (in)	N/A
N/A	Any Obstructions?	N/A	N/A	Storm Grate/Utility Hazard?	N/A
	Obstruction Type			Storm Grate/Utility Type

Two New Directional Ramps or Equivalent.

Remove & Replace Curb Ramp With
