## **Access Compliance Report Public Rights-of-Way** (Curb Ramps)

Intersection ID: 43662 Main Street: HUNTINGTON MEADOW LN Cross Street: CORSICA FOREST DR Location: SE

**ADA ID: EFFC1BAC85C8** Ramp Type: PerpDiag Initial Pass/Fail: Fail **Overall Compliance: No** Severity Score: 33.75

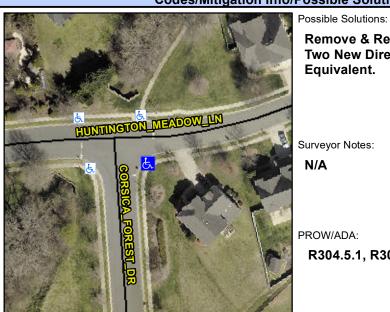
Equivalent. Surveyor Notes: N/A

Compliance Description		Data	Compliance Description		Data
N/A F	Ramp Length (in)	97.0	No	Ramp Slope (%)	9.0
No F	Ramp Width (in)	36.0	No	Ramp XSlope (%)	5.1
N/A F	Flare Type LT	N/A	N/A	Flare Type RT	N/A
N/A F	Flare Slope LT (%)	N/A	N/A	Flare Slope RT (%)	N/A
N/A F	lare Traversable LT?	N/A	N/A	Flare Traversable RT?	N/A
N/A L	anding Length (in)	N/A	N/A	DWS Provided?	N/A
N/A L	anding Width (in)	N/A	N/A	DWS Contrast?	N/A
N/A L	anding Slope (%)	N/A	N/A	DWS Length (in)	N/A
N/A L	anding X Slope (%)	N/A	N/A	DWS Full Width?	N/A
N/A L	anding Curb? (Y/N)	N/A	N/A	DWS Offset (in)	N/A
N/A S	Shared Landing?	N/A			
N/A	Gutter Ponding?	N/A	N/A	Gutter Slope (%)	N/A
N/A	Gutter Lip Ht (in)	N/A	N/A	Gutter X Slope (%)	N/A
N/A F	ainted X Walk1?	No	N/A	Painted X Walk2?	No
X	Walk 1 Direction	To N		X Walk 2 Direction	To W
N/A X	( Walk 1 Width (in)	N/A	N/A	X Walk 2 Width (in)	N/A
X	(Walk 1 Slope (%)	1.4		X Walk 2 Slope (%)	0.5
X	(Walk 1 X Slope (%)	0.3		X Walk 2 X Slope (%)	2.5

N/A F	Ramp inside XWalk1?	N/A	N/A	Ramp inside XWalk2?	N/A
F	Road Slope (%)	2.9	N/A	Clear Space?	N/A
F	Road X Slope (%)	3.5	N/A	Clear Space to XWalk (in)	N/A
N/A A	any Obstructions?	N/A	N/A	Storm Grate/Utility Hazard?	N/A
(	Obstruction Type			Storm Grate/Utility Type	
		N/A			N/A
			Yes	Surface Condition? (G/P)	Good

R304.5.1, R304.2.2, R304.5.3

**Two New Directional Ramps or**

Remove & Replace Curb Ramp With

Total Cost: 3200.00
