Access Compliance Report

Public Rights-of-Way

(Curb Ramps)

Intersection ID: 50729	Main Street: TODDINGTON_LN	Cross Street: ALDERGROVE_RD	Location: S
ADA ID: F014A8E43749	Ramp Type: PerpDiag	Initial Pass/Fail: Fail	Overall Compliance: No
		Severity Score: 10

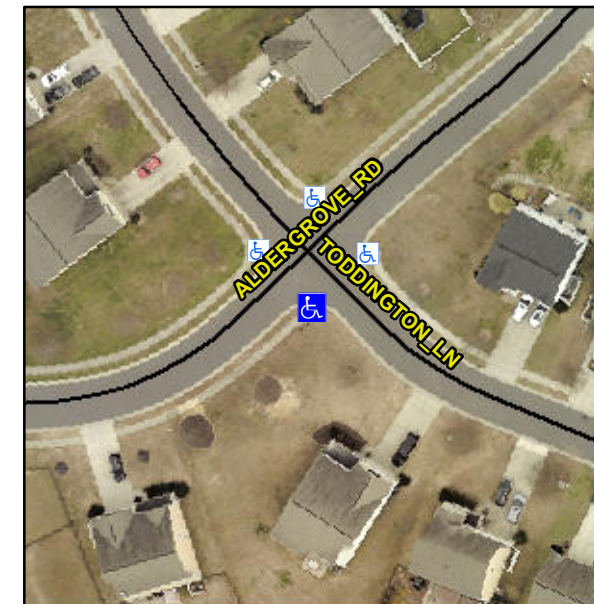
Compliance	Description	Data	Compliance	Description	Data
N/A	Ramp Length (in)	49.0	Yes	Ramp Slope (%)	6.2
No	Ramp Width (in)	47.0	No	Ramp XSlope (%)	3.4
N/A	Flare Type LT	N/A	N/A	Flare Type RT	N/A
N/A	Flare Slope LT (%)	N/A	N/A	Flare Slope RT (%)	N/A
N/A	Flare Traversable LT?	N/A	N/A	Flare Traversable RT?	N/A
N/A	Landing Length (in)	N/A	N/A	DWS Provided?	N/A
N/A	Landing Width (in)	N/A	N/A	DWS Contrast?	N/A
N/A	Landing Slope (%)	N/A	N/A	DWS Length (in)	N/A
N/A	Landing X Slope (%)	N/A	N/A	DWS Full Width?	N/A
N/A	Landing Curb? (Y/N)	N/A	N/A	DWS Offset (in)	N/A
N/A	Shared Landing?	N/A			
N/A	Gutter Ponding?	N/A	N/A	Gutter Slope (%)	N/A
N/A	Gutter Lip Ht (in)	N/A	N/A	Gutter X Slope (%)	N/A
N/A	Painted X Walk1?	No	N/A	Painted X Walk2?	No
	X Walk 1 Direction	To NE		X Walk 2 Direction	To NW
N/A	X Walk 1 Width (in)	N/A	N/A	X Walk 2 Width (in)	N/A
	X Walk 1 Slope (%)	3.2		X Walk 2 Slope (%)	2.5
	X Walk 1 X Slope (%)	2.1		X Walk 2 X Slope (%)	4.2

N/A	Ramp inside XWalk1?	N/A	N/A	Ramp inside XWalk2?	N/A
	Road Slope (%)	4.3	N/A	Clear Space?	N/A
	Road X Slope (%)	0.2	N/A	Clear Space to XWalk (in)	N/A
N/A	Any Obstructions?	N/A	N/A	Storm Grate/Utility Hazard?	N/A
	Obstruction Type			Storm Grate/Utility Type	
		N/A			N/A
			Yes	Surface Condition? (G/P)	Good

Remove & Replace Curb Ramp With Two New Directional Ramps or Equivalent.

R304.5.1, R304.5.3
