# Access Compliance Report

## Public Rights-of-Way

### (Curb Ramps)

Intersection ID: 13749	Main Street: BARRINGER_DR	Cross Street: REMOUNT_RD	Location: SW
ADA ID: F01F59F566A9	Ramp Type: PerpDiag	Initial Pass/Fail: Fail	Overall Compliance: No
Severity Score: 25			
Codes/Mitigation Info/Possible Solution		Field Measurements/Component Compliance

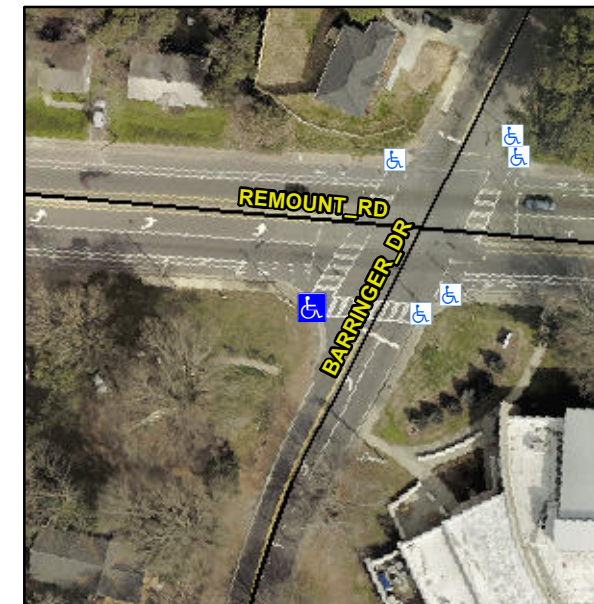
Compliance	Description	Data	Compliance	Description	Data
N/A	Ramp Length (in)	58.0	No	Ramp Slope (%)	12.2
Yes	Ramp Width (in)	48.0	Yes	Ramp XSlope (%)	2.0
N/A	Flare Type LT	N/A	N/A	Flare Type RT	N/A
N/A	Flare Slope LT (%)	N/A	N/A	Flare Slope RT (%)	N/A
N/A	Flare Traversable LT?	N/A	N/A	Flare Traversable RT?	N/A
N/A	Landing Length (in)	N/A	N/A	DWS Provided?	N/A
N/A	Landing Width (in)	N/A	N/A	DWS Contrast?	N/A
N/A	Landing Slope (%)	N/A	N/A	DWS Length (in)	N/A
N/A	Landing X Slope (%)	N/A	N/A	DWS Full Width?	N/A
N/A	Landing Curb? (Y/N)	N/A	N/A	DWS Offset (in)	N/A
N/A	Shared Landing?	N/A			
N/A	Gutter Ponding?	N/A	N/A	Gutter Slope (%)	N/A
N/A	Gutter Lip Ht (in)	N/A	N/A	Gutter X Slope (%)	N/A
N/A	Painted X Walk1?	Yes	N/A	Painted X Walk2?	Yes
	X Walk 1 Direction	To E		X Walk 2 Direction	To NE
N/A	X Walk 1 Width (in)	118.0	N/A	X Walk 2 Width (in)	123.0
	X Walk 1 Slope (%)	1.7		X Walk 2 Slope (%)	1.9
	X Walk 1 X Slope (%)	0.5		X Walk 2 X Slope (%)	1.6

N/A	Ramp inside XWalk1?	Yes	N/A	Ramp inside XWalk2?	Yes
	Road Slope (%)	0.5	N/A	Clear Space?	N/A
	Road X Slope (%)	2.3	N/A	Clear Space to XWalk (in)	N/A
N/A	Any Obstructions?	N/A	N/A	Storm Grate/Utility Hazard?	N/A
	Obstruction Type			Storm Grate/Utility Type	
		N/A			N/A
		Yes		Surface Condition? (G/P)	Good

Possible Solutions:

**Remove & Replace Curb Ramp With Two New Directional Ramps or Equivalent.**
