# Access Compliance Report

## Public Rights-of-Way

### (Curb Ramps)

| Intersection ID: 9325 | Main Street: FREEDOM_DR | Cross Street: MARLENE_ST | Location: S |

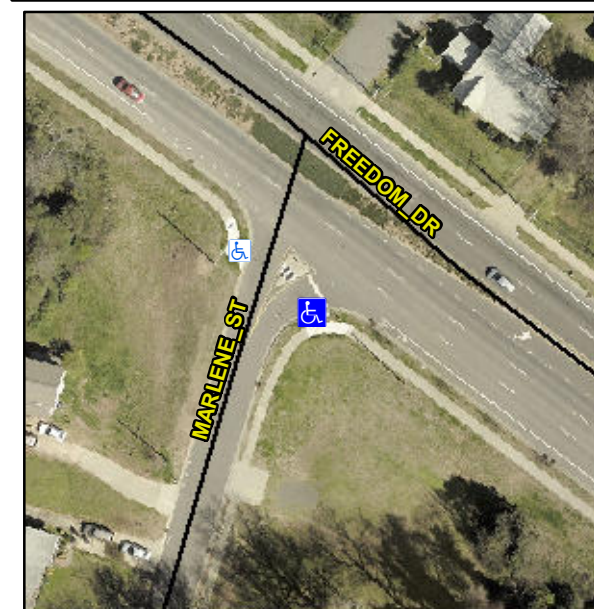
| ADA ID: F024F1BDF2D3 | Ramp Type: Perp | Initial Pass/Fail: Fail | Overall Compliance: No |
| Severity Score: 33.75 | | | |

**Not Found, R304.5.1, R304.5.3**

| Compliance | Description | Data | Compliance | Description | Data |
|---|---|---|---|---|---|
| N/A | Ramp Length (in) | 60.0 | Yes | Ramp Slope (%) | 7.4 |
| No | Ramp Width (in) | 47.5 | No | Ramp XSlope (%) | 8.0 |

Possible Solutions:

**Remove & Replace Entire Ramp.**

Total Cost: \$ 1850.00
