Access Compliance Report

Public Rights-of-Way

(Curb Ramps)

Intersection ID: 11912	Main Street: W_1ST_ST	Cross Street: MCNINCH_ST	Location: S
ADA ID: F025C1DAC2D7	Ramp Type: PerpDiag	Initial Pass/Fail: Fail	Overall Compliance: No
			Severity Score: 31.25

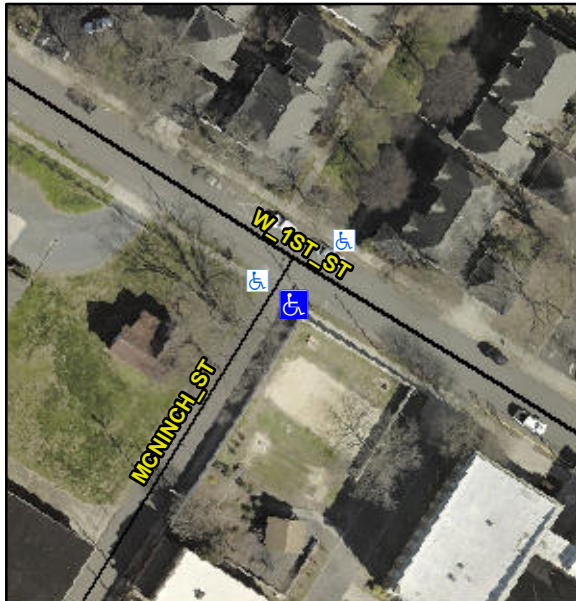
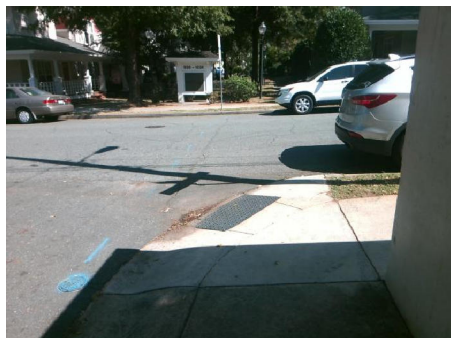
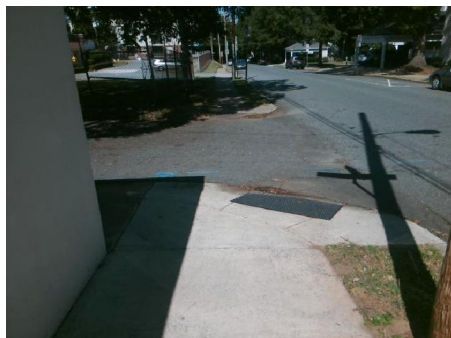
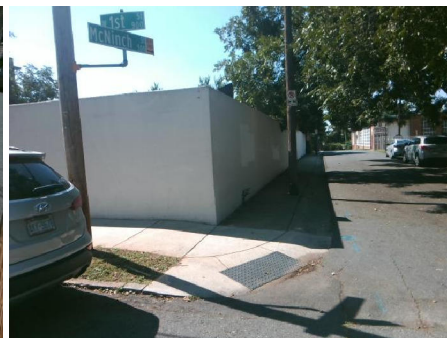
Not Found, R304.5.1, R304.2.2, R304.5.3

Compliance	Description	Data	Compliance	Description	Data
N/A	Ramp Length (in)	40.0	No	Ramp Slope (%)	11.7
No	Ramp Width (in)	34.0	No	Ramp XSlope (%)	3.0
N/A	Flare Type LT	N/A	N/A	Flare Type RT	N/A
N/A	Flare Slope LT (%)	N/A	N/A	Flare Slope RT (%)	N/A
N/A	Flare Traversable LT?	N/A	N/A	Flare Traversable RT?	N/A
N/A	Landing Length (in)	N/A	N/A	DWS Provided?	N/A
N/A	Landing Width (in)	N/A	N/A	DWS Contrast?	N/A
N/A	Landing Slope (%)	N/A	N/A	DWS Length (in)	N/A
N/A	Landing X Slope (%)	N/A	N/A	DWS Full Width?	N/A
N/A	Landing Curb? (Y/N)	N/A	N/A	DWS Offset (in)	N/A
N/A	Shared Landing?	N/A			
N/A	Gutter Ponding?	N/A	N/A	Gutter Slope (%)	N/A
N/A	Gutter Lip Ht (in)	N/A	N/A	Gutter X Slope (%)	N/A
N/A	Painted X Walk1?	No	N/A	Painted X Walk2?	No
	X Walk 1 Direction	To NE		X Walk 2 Direction	To NW
N/A	X Walk 1 Width (in)	N/A	N/A	X Walk 2 Width (in)	N/A
	X Walk 1 Slope (%)	3.9		X Walk 2 Slope (%)	1.7
	X Walk 1 X Slope (%)	4.6		X Walk 2 X Slope (%)	2.7

N/A	Ramp inside XWalk1?	N/A	N/A	Ramp inside XWalk2?	N/A
	Road Slope (%)	1.5	N/A	Clear Space?	N/A
	Road X Slope (%)	3.2	N/A	Clear Space to XWalk (in)	N/A
N/A	Any Obstructions?	N/A	N/A	Storm Grate/Utility Hazard?	N/A
	Obstruction Type			Storm Grate/Utility Type	
		N/A			N/A
			Yes	Surface Condition? (G/P)	Good

Remove & Replace Curb Ramp With Two New Directional Ramps or Equivalent.
