# Access Compliance Report

## Public Rights-of-Way

### (Curb Ramps)

Intersection ID: 13985	Main Street: CAMDEN_RD	Cross Street: EAST_BV	Location: NE
ADA ID: F02D38210A58	Ramp Type: Perp	Initial Pass/Fail: Fail	Overall Compliance: No
		Severity Score: 37.5

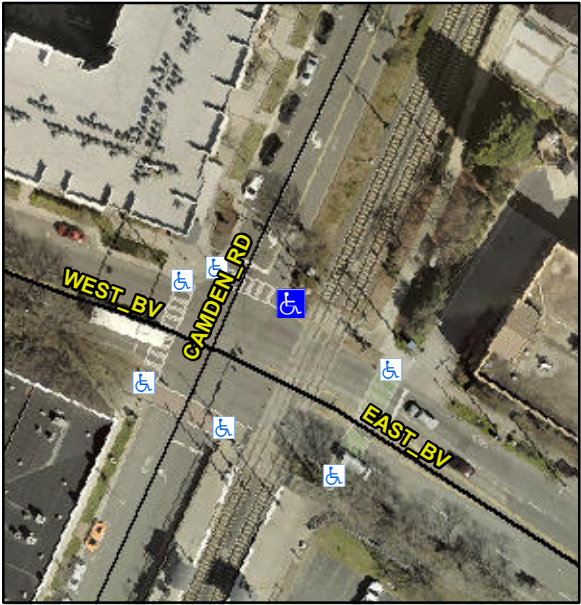
Possible Solutions:		<b>Compliance</b>	<b>Description</b>	<b>Data</b>
	<b>Remove &amp; Replace Entire Ramp.</b>		<b>No</b>	Ramp Length (in)	50.0
			<b>Yes</b>	Ramp Width (in)	48.0
			<b>N/A</b>	Flare Type LT	N/A
			<b>N/A</b>	Flare Slope LT (%)	N/A
			<b>N/A</b>	Flare Traversable LT?	N/A
			<b>N/A</b>	Landing Length (in)	N/A
			<b>N/A</b>	Landing Width (in)	N/A
			<b>N/A</b>	Landing Slope (%)	N/A
			<b>N/A</b>	Landing X Slope (%)	N/A
<p>Surveyor Notes:</p> <p><b>N/A</b></p> <p>PROW/ADA:</p> <p><b>R304.2.2, R304.5.3</b></p>			<b>N/A</b>	Flare Type RT	N/A
			<b>N/A</b>	Flare Slope RT (%)	N/A
			<b>N/A</b>	Flare Traversable RT?	N/A
			<b>N/A</b>	DWS Provided?	N/A
			<b>N/A</b>	DWS Contrast?	N/A
			<b>N/A</b>	DWS Length (in)	N/A
			<b>N/A</b>	DWS Full Width?	N/A
			<b>N/A</b>	DWS Offset (in)	N/A
			<b>N/A</b>	Shared Landing?	N/A

<b>N/A</b>	Gutter Ponding?	N/A
			<b>N/A</b>	Gutter Lip Ht (in)	N/A
			<b>N/A</b>	Painted X Walk1?	Yes
				X Walk 1 Direction	To NW
			<b>N/A</b>	X Walk 1 Width (in)	99.0
				X Walk 1 Slope (%)	1.6
				X Walk 1 X Slope (%)	10.0
			<b>N/A</b>	Ramp inside XWalk1?	Yes
			<b>N/A</b>	Road Slope (%)	N/A
			<b>N/A</b>	Road X Slope (%)	N/A
			<b>N/A</b>	Any Obstructions?	N/A
				Obstruction Type	
			<b>N/A</b>		
			<b>N/A</b>		
			<b>N/A</b>		
			<b>N/A</b>		
			<b>N/A</b>		
			<b>N/A</b>		
			<b>N/A</b>		
			<b>N/A</b>		
			<b>N/A</b>		
Total Cost:		\$ 1850.00			
			<b>N/A</b>		
			<b>Yes</b>	Surface Condition? (G/P)	Good
