# Access Compliance Report

## Public Rights-of-Way

### (Curb Ramps)

Intersection ID: 10350	Main Street: BANCROFT_ST	Cross Street: KESWICK_AV	Location: S
ADA ID: F0332CC0FAD1	Ramp Type: BlendTrans1	Initial Pass/Fail: Fail	Overall Compliance: No
		Severity Score: 10

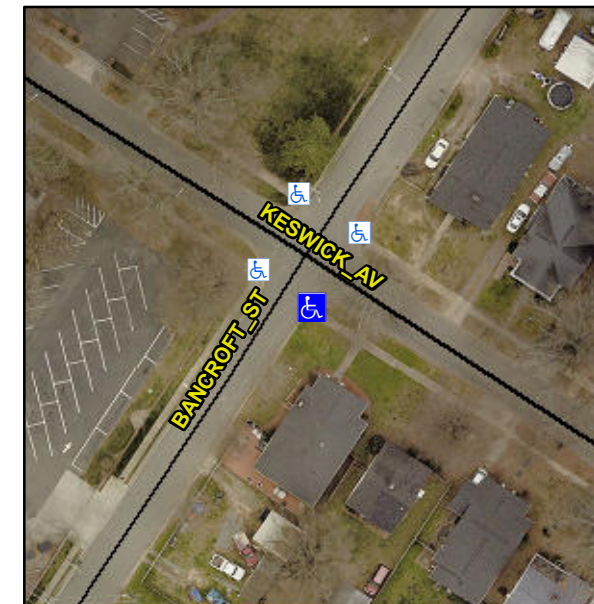
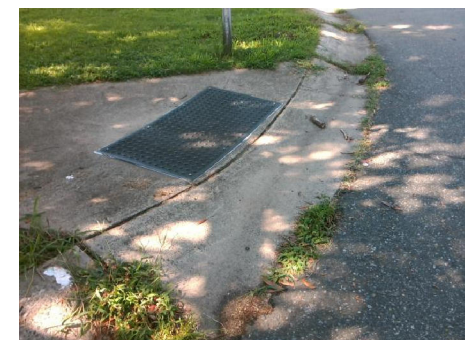
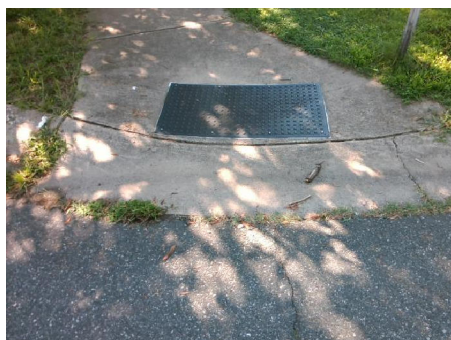
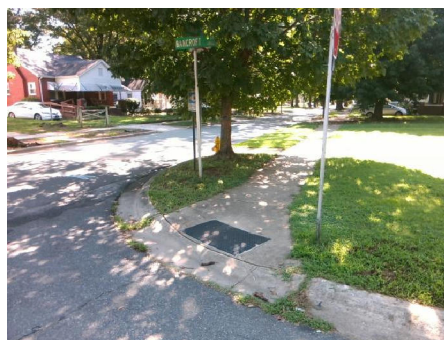
**Not Found, R304.5.1, R304.5.3**

Compliance	Description	Data	Compliance	Description	Data
N/A	Ramp Length (in)	50.5	Yes	BlendTrans Slope (%)	4.2
No	Ramp Width (in)	46.0	No	BlendTrans XSlope (%)	2.2
N/A	Flare Type LT	N/A	N/A	Flare Type RT	N/A
N/A	Flare Slope LT (%)	N/A	N/A	Flare Slope RT (%)	N/A
N/A	Flare Traversable LT?	N/A	N/A	Flare Traversable RT?	N/A
N/A	Landing Length (in)	N/A	N/A	DWS Provided?	N/A
N/A	Landing Width (in)	N/A	N/A	DWS Contrast?	N/A
N/A	Landing Slope (%)	N/A	N/A	DWS Length (in)	N/A
N/A	Landing X Slope (%)	N/A	N/A	DWS Full Width?	N/A
N/A	Landing Curb? (Y/N)	N/A	N/A	DWS Offset (in)	N/A
N/A	Shared Landing?	N/A			
N/A	Gutter Ponding?	N/A	N/A	Gutter Slope (%)	N/A
N/A	Gutter Lip Ht (in)	N/A	N/A	Gutter X Slope (%)	N/A
N/A	Painted X Walk1?	No	N/A	Painted X Walk2?	No
	X Walk 1 Direction	To NE		X Walk 2 Direction	To NW
	X Walk 1 Width (in)	N/A		X Walk 2 Width (in)	N/A
	X Walk 1 Slope (%)	3.3		X Walk 2 Slope (%)	3.5
	X Walk 1 X Slope (%)	1.5		X Walk 2 X Slope (%)	2.8

N/A	Ramp inside XWalk1?	N/A	N/A	Ramp inside XWalk2?	N/A
	Road Slope (%)	3.4		Clear Space?	N/A
	Road X Slope (%)	2.0	N/A	Clear Space to XWalk (in)	N/A
N/A	Any Obstructions?	N/A	N/A	Storm Grate/Utility Hazard?	N/A
	Obstruction Type			Storm Grate/Utility Type	
		N/A			N/A
			Yes	Surface Condition? (G/P)	Good
			No	Curb Slope (%)	12.5

**Remove & Replace Curb Ramp With Two New Directional Ramps or Equivalent.**
