Intersection ID: 30005	Main Street: BACKWATER_DR	Cross Street: BRIGHTHAVEN_LN	Location:	NW
ADA ID: F03AF1223F5A	Ramp Type: Perp	Initial Pass/Fail: Fail	Overall Compliance: No	Severity Score: 22.5

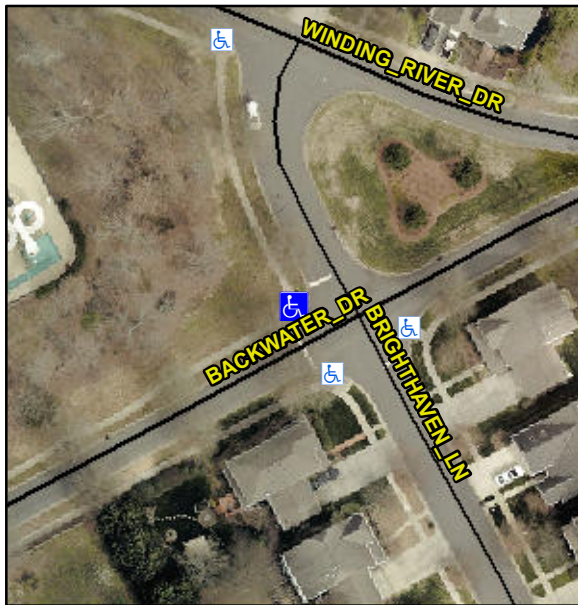
**Not Found, R304.5.1, R304.2.2,
R304.5.3**

Compliance	Description	Data	Compliance	Description	Data
N/A	Ramp Length (in)	97.0	No	Ramp Slope (%)	8.4
No	Ramp Width (in)	47.5	No	Ramp XSlope (%)	2.6
N/A	Flare Type LT	N/A	N/A	Flare Type RT	N/A
N/A	Flare Slope LT (%)	N/A	N/A	Flare Slope RT (%)	N/A
N/A	Flare Traversable LT?	N/A	N/A	Flare Traversable RT?	N/A
N/A	Landing Length (in)	N/A	N/A	DWS Provided?	N/A
N/A	Landing Width (in)	N/A	N/A	DWS Contrast?	N/A
N/A	Landing Slope (%)	N/A	N/A	DWS Length (in)	N/A
N/A	Landing X Slope (%)	N/A	N/A	DWS Full Width?	N/A
N/A	Landing Curb? (Y/N)	N/A	N/A	DWS Offset (in)	N/A
N/A	Shared Landing?	N/A			
N/A	Gutter Ponding?	N/A	N/A	Gutter Slope (%)	N/A
N/A	Gutter Lip Ht (in)	N/A	N/A	Gutter X Slope (%)	N/A
N/A	Painted X Walk1?	No	N/A	Painted X Walk2?	N/A
	X Walk 1 Direction	To S		X Walk 2 Direction	N/A
N/A	X Walk 1 Width (in)	N/A	N/A	X Walk 2 Width (in)	N/A
	X Walk 1 Slope (%)	0.5		X Walk 2 Slope (%)	N/A
	X Walk 1 X Slope (%)	2.6		X Walk 2 X Slope (%)	N/A

N/A	Ramp inside XWalk1?	N/A	N/A	Ramp inside XWalk2?	N/A
	Road Slope (%)	N/A	N/A	Clear Space?	N/A
	Road X Slope (%)	N/A	N/A	Clear Space to XWalk (in)	N/A
N/A	Any Obstructions?	N/A	N/A	Storm Grate/Utility Hazard?	N/A
	Obstruction Type			Storm Grate/Utility Type	
		N/A			N/A
			Yes	Surface Condition? (G/P)	Good

Remove & Replace Entire Ramp.
