## **Access Compliance Report Public Rights-of-Way** (Curb Ramps)

Intersection ID: 30503 Main Street: SHARON RD Cross Street: QUAIL PARK DR Location: NE **Overall Compliance: No Severity Score:** ADA ID: F048BDDE36B6 Ramp Type: BlendTrans2 Initial Pass/Fail: Fail 8.75

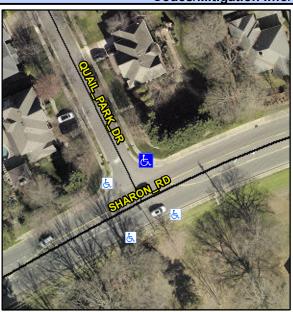
Street 1 Name Stop Condition-Street 1 Street 2 Name Stop Condition-Street 2 **QUAIL PARK DR** StopSign **SHARON RD** None Possible Solutions: Remove & Replace Curb Ramp With Two New Directional Ramps or Equivalent. Surveyor Notes: N/A

Yes No Ramp Width (in) 47.0 BlendTrans XSlope (%) 0.6 N/A N/A Flare Type LT N/A Flare Type RT N/A N/A Flare Slope LT (%) N/A N/A Flare Slope RT (%) N/A N/A Flare Traversable LT? N/A N/A Flare Traversable RT? N/A N/A Landing Length (in) N/A N/A **DWS Provided?** N/A N/A Landing Width (in) N/A N/A **DWS Contrast?** N/A N/A N/A N/A Landing Slope (%) DWS Length (in) N/A N/A Landing X Slope (%) N/A N/A DWS Full Width? N/A N/A Landing Curb? (Y/N) N/A N/A DWS Offset (in) N/A N/A N/A Shared Landing? N/A **Gutter Ponding?** N/A N/A Gutter Slope (%) N/A N/A Gutter Lip Ht (in) N/A N/A Gutter X Slope (%) N/A N/A Painted X Walk1? No N/A Painted X Walk2? No X Walk 1 Direction To SW X Walk 2 Direction To SE N/A X Walk 1 Width (in) X Walk 2 Width (in) N/A X Walk 1 Slope (%) 3.6 X Walk 2 Slope (%) 0.7 X Walk 1 X Slope (%) 0.3 X Walk 2 X Slope (%) 3.3 N/A N/A Ramp inside XWalk2? N/A N/A Ramp inside XWalk1? Road Slope (%) 0.9 Clear Space? N/A Road X Slope (%) 3.2 N/A Clear Space to XWalk (in) N/A N/A N/A N/A Any Obstructions? Storm Grate/Utility Hazard? N/A **Obstruction Type** Storm Grate/Utility Type N/A N/A Yes Surface Condition? (G/P) Good No Curb Slope (%) 10.3
