Access Compliance Report Public Rights-of-Way (Curb Ramps)

-		-	-						
Intersection ID: 11110	Main Street: E_16TH_ST			Cross	Street:	N_TRYON_ST	Location:	SW			
ADA ID: F04BAE02D1CA	CA Ramp Type: Perp			Initial	Pass/Fa	ail: Fail Overall	o Severity Score:	22.5			
Codes/Mitigation Info/Possible Solution					Field Measurements/Component Compliance						
<u>G</u>	1	Possible Solutions:			Compliance Description Data			Compliance Description		Data	
	1	Remove & Replace Entir	e Ram	p.	N/A	Ramp Length (in)	64.0	No	Ramp Slope (%)	8.7	
					No	Ramp Width (in)	47.0	No	Ramp XSlope (%)	2.7	
					N/A	Flare Type LT	N/A	N/A	Flare Type RT	N/A	
	· Salar				N/A	Flare Slope LT (%)	N/A	N/A	Flare Slope RT (%)	N/A	
the second second	No The Street				N/A	Flare Traversable LT?	N/A	N/A	Flare Traversable RT?	N/A	
and shall	B m				N/A	Landing Length (in)	N/A	N/A	DWS Provided?	N/A

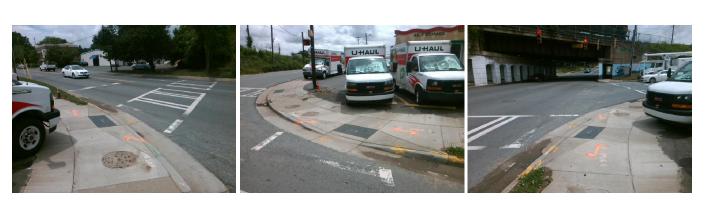
1. 11 10 51				N/A	Shared Landing?	N/A					
	No. 1	PROW/ADA:			N/A	Gutter Ponding?	N/A	N/A	Gutter Slope (%)	N/A	
	6 The	Not Found, R304.5.1, R3	304.2.2.		N/A	Gutter Lip Ht (in)	N/A	N/A	Gutter X Slope (%)	N/A	
	R304.5.3	,		N/A	Painted X Walk1?	Yes	N/A	Painted X Walk2?	N/A		
11/1000 2. 27-2					X Walk 1 Direction	To NW		X Walk 2 Direction	N/A		
					N/A	X Walk 1 Width (in)	115.0	N/A	X Walk 2 Width (in)	N/A	
Street 1 Name	N TRYON ST					X Walk 1 Slope (%)	1.3		X Walk 2 Slope (%)	N/A	
Stop Condition-Street 2	Signal					X Walk 1 X Slope (%)	1.5		X Walk 2 X Slope (%)	N/A	
Street 2 Name	N/A				N/A	Ramp inside XWalk1?	Yes	N/A	Ramp inside XWalk2?	N/A	
Stop Condition-Street 1	N/A					Road Slope (%)	N/A	N/A	Clear Space?	N/A	
						Road X Slope (%)	N/A	N/A	Clear Space to XWalk (in)	N/A	
					N/A	Any Obstructions?	N/A	N/A	Storm Grate/Utility Hazard?	N/A	
		Total Cost:	\$	1850.00		Obstruction Type			Storm Grate/Utility Type
