Access Compliance Report

Public Rights-of-Way

(Curb Ramps)

| Intersection ID: 9440 | Main Street: BRADFORD_DR | Cross Street: EDGEWOOD_RD | Location: W |

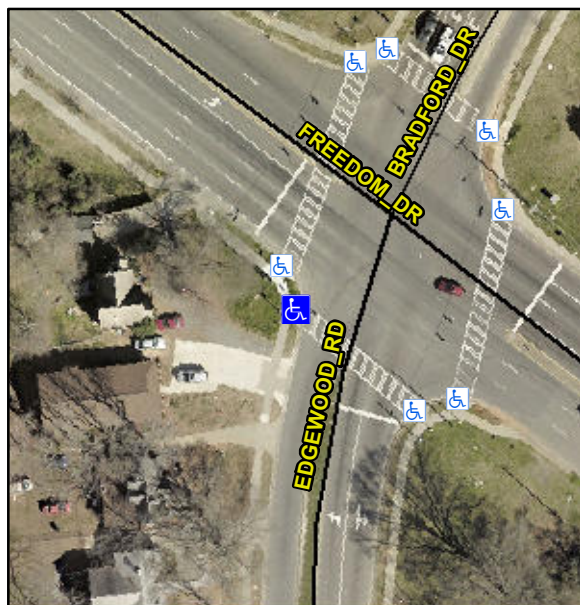
| ADA ID: F0591B48C5E2 | Ramp Type: Perp | Initial Pass/Fail: Fail | Overall Compliance: No |

Not Found, R304.2.2

| Compliance | Description | Data | Compliance | Description | Data |
|---|---|---|---|---|---|
| N/A | Ramp Length (in) | 60.0 | No | Ramp Slope (%) | 9.5 |

Remove & Replace Entire Ramp.

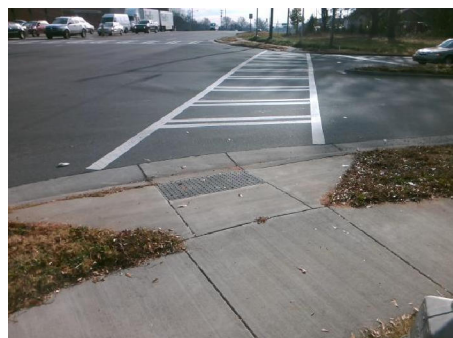
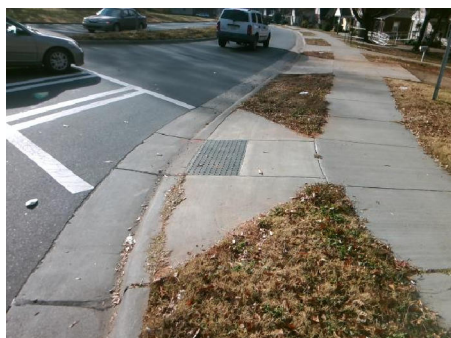
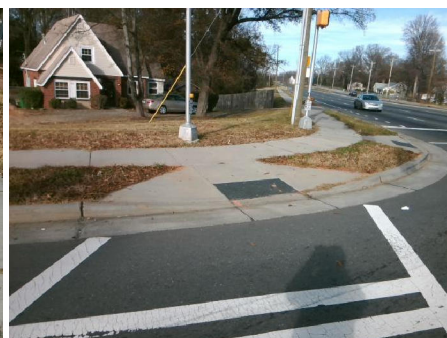
| Compliance | Description | Data | Compliance | Description | Data |
|---|---|---|---|---|---|
| Yes | Ramp Width (in) | 48.0 | Yes | Ramp XSlope (%) | 0.5 |
| | | Yes | | Surface Condition? (G/P) | Good |
