## **Access Compliance Report Public Rights-of-Way** (Curb Ramps)

Intersection ID: 49386 Main Street: DAMASCUS ST **Cross Street: SOUTH DEVON ST** Location: NW **Overall Compliance: No Severity Score:** ADA ID: F05DFA7AF156 Ramp Type: BlendTrans1 Initial Pass/Fail: Fail 8.75

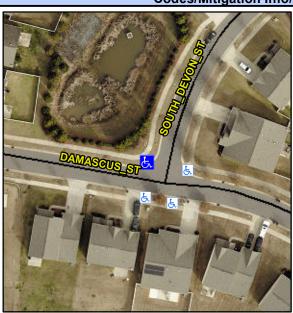
Total Cost: 3200.00 Compliance Description Data Compliance Description Data Yes N/A Ramp Length (in) 92.0 BlendTrans Slope (%) 3.7 Yes No Ramp Width (in) 46.5 BlendTrans XSlope (%) 1.8 N/A N/A Flare Type LT N/A Flare Type RT N/A N/A Flare Slope LT (%) N/A N/A Flare Slope RT (%) N/A N/A Flare Traversable LT? N/A N/A Flare Traversable RT? N/A N/A Landing Length (in) N/A N/A **DWS Provided?** N/A N/A Landing Width (in) N/A N/A **DWS Contrast?** N/A N/A N/A N/A Landing Slope (%) DWS Length (in) N/A N/A Landing X Slope (%) N/A N/A DWS Full Width? N/A N/A Landing Curb? (Y/N) N/A N/A DWS Offset (in) N/A N/A N/A Shared Landing? N/A **Gutter Ponding?** N/A N/A Gutter Slope (%) N/A N/A Gutter Lip Ht (in) 1.0 N/A Gutter X Slope (%) N/A N/A Painted X Walk1? No N/A Painted X Walk2? No X Walk 1 Direction To S X Walk 2 Direction To E N/A X Walk 1 Width (in) X Walk 2 Width (in) N/A X Walk 1 Slope (%) 2.6 X Walk 2 Slope (%) 3.4 X Walk 1 X Slope (%) 5.2 X Walk 2 X Slope (%) 3.0 N/A N/A Ramp inside XWalk2? N/A N/A Ramp inside XWalk1? Road Slope (%) 0.0 Clear Space? N/A N/A Road X Slope (%) 5.0 Clear Space to XWalk (in) N/A N/A N/A N/A Any Obstructions? Storm Grate/Utility Hazard? N/A Obstruction Type Storm Grate/Utility Type N/A N/A Yes Surface Condition? (G/P) Good No 5.4

Curb Slope (%)

**DAMASCUS ST** Street 1 Name Stop Condition-Street 1 None **SOUTH DEVON ST** Street 2 Name Stop Condition-Street 2 StopSign Possible Solutions: Remove & Replace Curb Ramp With Two New Directional Ramps or Equivalent. Surveyor Notes: N/A PROW/ADA: Not Found, R304.5.1
