Access Compliance Report

Public Rights-of-Way

(Curb Ramps)

| Intersection ID: 5714 | Main Street: JOHN_KIRK_DR | Cross Street: UNIVERSITY_CITY_BV | Location: NW |

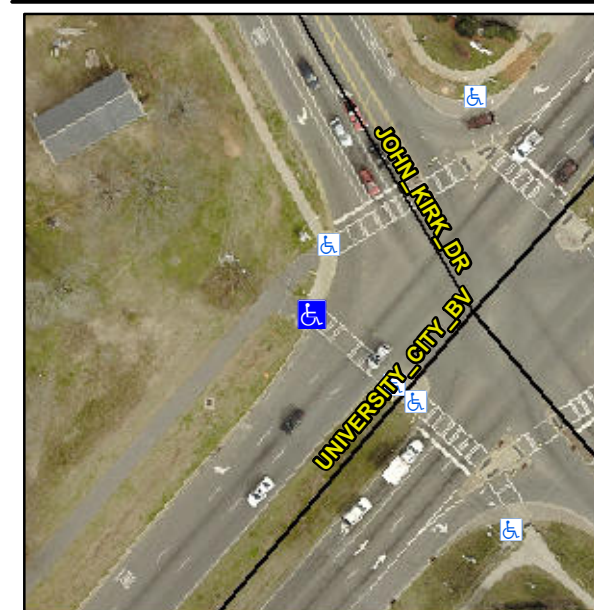
| ADA ID: F09B5F420005 | Ramp Type: Perp | Initial Pass/Fail: Fail | Overall Compliance: No |
| Severity Score: 21.25 | | | |

Not Found, R304.5.1, R304.2.2

| Compliance | Description | Data | Compliance | Description | Data |
|---|---|---|---|---|---|
| N/A | Ramp Length (in) | 75.0 | No | Ramp Slope (%) | 9.0 |
| No | Ramp Width (in) | 46.0 | Yes | Ramp XSlope (%) | 0.5 |

Remove & Replace Entire Ramp.
