# Access Compliance Report

## Public Rights-of-Way

### (Curb Ramps)

| Intersection ID: 18943 | Main Street: GATE_POST_RD | Cross Street: RAMA_RD | Location: | N |

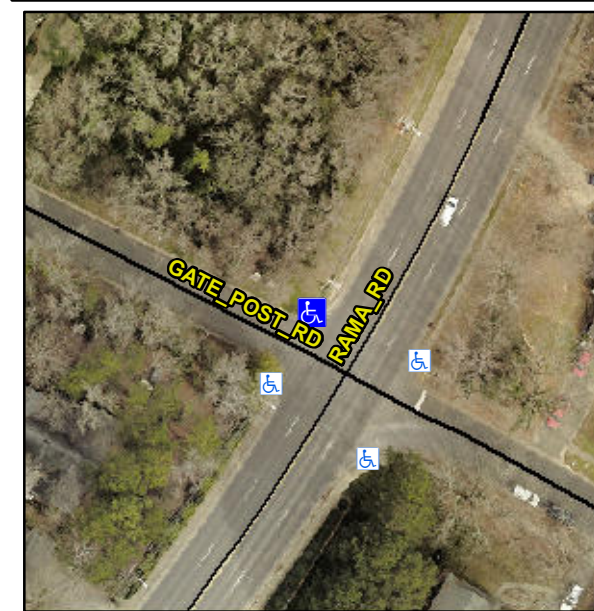
| ADA ID: F0A5E673EF1F | Ramp Type: PerpDiag | Initial Pass/Fail: Fail | Overall Compliance: No | Severity Score: 37.5 |

**Not Found, R304.2.2, R304.5.3**

| Compliance | Description | Data | Compliance | Description | Data |
|---|---|---|---|---|---|
| N/A | Ramp Length (in) | 58.0 | No | Ramp Slope (%) | 9.9 |
| Yes | Ramp Width (in) | 48.0 | No | Ramp XSlope (%) | 7.8 |

**Remove & Replace Curb Ramp With Two New Directional Ramps or Equivalent.**
