Access Compliance Report Public Rights-of-Way (Curb Ramps)

Intersection ID: 11349 Main Street: N_DAVIDSON_ST Cross Street: PARKWOOD_AV Location: N **Overall Compliance: No** 10 **ADA ID: F0A6F17277CC** Ramp Type: Perp Initial Pass/Fail: Fail **Severity Score:**

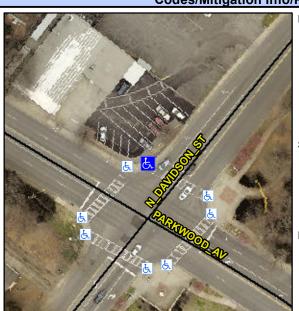
Field Measurements/Component Compliance							
Comp	liance Description	Data	Comp	liance	Description	Data	
N/A	Ramp Length (in)	67.5	Yes	Ramp	Slope (%)	8.2	
No	Ramp Width (in)	47.0	Yes	Ramp	XSlope (%)	2.5	
N/A	Flare Type LT	N/A	N/A	Flare	Type RT	N/A	
N/A	Flare Slope LT (%)	N/A	N/A	Flare	Slope RT (%)	N/A	
N/A	Flare Traversable LT?	N/A	N/A	Flare	Traversable RT?	N/A	
N/A	Landing Length (in)	N/A	N/A	DWS	Provided?	N/A	
N/A	Landing Width (in)	N/A	N/A	DWS	Contrast?	N/A	
N/A	Landing Slope (%)	N/A	N/A	DWS	Length (in)	N/A	
N/A	Landing X Slope (%)	N/A	N/A	DWS	Full Width?	N/A	
N/A	Landing Curb? (Y/N)	N/A	N/A	DWS	Offset (in)	N/A	
N/A	Shared Landing?	N/A					
N/A	Gutter Ponding?	N/A	N/A	Gutte	r Slope (%)	N/A	
N/A	Gutter Lip Ht (in)	N/A	N/A	Gutte	er X Slope (%)	N/A	
N/A	Painted X Walk1?	Yes	N/A	Paint	ed X Walk2?	N/A	
	X Walk 1 Direction	To SE		X Wa	lk 2 Direction	N/A	
N/A	X Walk 1 Width (in)	106.0	N/A	X Wa	lk 2 Width (in)	N/A

X Walk 1 Slope (%)	2.2		X Wa	lk 2 Slope (%)	N/A	
	X Walk 1 X Slope (%)	2.6		X Wa	lk 2 X Slope (%)	N/A	
N/A	Ramp inside XWalk1?	Yes	N/A	Ram	inside XWalk2?	N/A	
	Road Slope (%)	N/A	N/A	Clear	Space?	N/A	
	Road X Slope (%)	N/A	N/A	Clear	Space to XWalk (in)	N/A	
N/A	Any Obstructions?	N/A	N/A	Storn	n Grate/Utility Hazard?	N/A	
	Obstruction Type			Storn	n Grate/Utility Type		
		N/A				N/A	
			Yes	Surfa	ce Condition? (G/P)	Good	
10

Possible Solution	
Possible Solutions:	Co
Remove & Replace Entire Ramp.	N/A
·	No
	N/A
	N/A
	N/A
	N/A
Surveyor Notes:	N/A
N/A	N/A
	N/A
	N/A
	N/A
PROW/ADA:	N/A
Not Found, R304.5.1	N/A
·	N/A
	N/A

Total Cost:	\$ 1850.00
