Access Compliance Report

Public Rights-of-Way (Curb Ramps)

Intersection ID: N/A	Main Street: MARKLAND_DR	Cross Street: ELKMONT_PL	Location: SE
ADA ID: F0AACD56635C	Ramp Type: PerpDiag	Initial Pass/Fail: Fail	Overall Compliance: No
Severity Score: 8.75			
Codes/Mitigation Info/Possible Solution		Field Measurements/Component Compliance

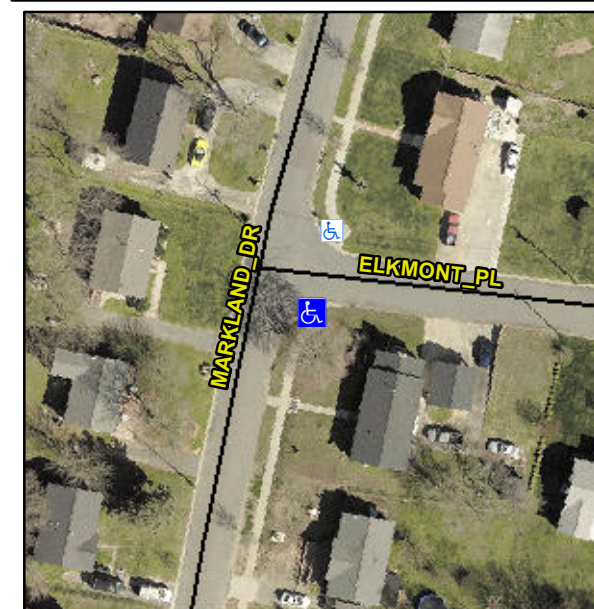
Not Found, R304.5.1

Compliance	Description	Data	Compliance	Description	Data
N/A	Ramp Length (in)	73.0	Yes	Ramp Slope (%)	6.4
No	Ramp Width (in)	47.0	Yes	Ramp XSlope (%)	0.2
N/A	Flare Type LT	N/A	N/A	Flare Type RT	N/A
N/A	Flare Slope LT (%)	N/A	N/A	Flare Slope RT (%)	N/A
N/A	Flare Traversable LT?	N/A	N/A	Flare Traversable RT?	N/A
N/A	Landing Length (in)	N/A	N/A	DWS Provided?	N/A
N/A	Landing Width (in)	N/A	N/A	DWS Contrast?	N/A
N/A	Landing Slope (%)	N/A	N/A	DWS Length (in)	N/A
N/A	Landing X Slope (%)	N/A	N/A	DWS Full Width?	N/A
N/A	Landing Curb? (Y/N)	N/A	N/A	DWS Offset (in)	N/A
N/A	Shared Landing?	N/A			
N/A	Gutter Ponding?	N/A	N/A	Gutter Slope (%)	N/A
N/A	Gutter Lip Ht (in)	N/A	N/A	Gutter X Slope (%)	N/A
N/A	Painted X Walk1?	No	N/A	Painted X Walk2?	No
	X Walk 1 Direction	To NE		X Walk 2 Direction	To W
N/A	X Walk 1 Width (in)	N/A	N/A	X Walk 2 Width (in)	N/A
	X Walk 1 Slope (%)	4.8		X Walk 2 Slope (%)	2.9
	X Walk 1 X Slope (%)	1.7		X Walk 2 X Slope (%)	3.0

N/A	Ramp inside XWalk1?	N/A	N/A	Ramp inside XWalk2?	N/A
	Road Slope (%)	1.0	N/A	Clear Space?	N/A
	Road X Slope (%)	3.9	N/A	Clear Space to XWalk (in)	N/A
N/A	Any Obstructions?	N/A	N/A	Storm Grate/Utility Hazard?	N/A
	Obstruction Type			Storm Grate/Utility Type	
		N/A			N/A
		Yes		Surface Condition? (G/P)	Good

Possible Solutions:

Remove & Replace Curb Ramp With Two New Directional Ramps or Equivalent.
