# Access Compliance Report

## Public Rights-of-Way

### (Curb Ramps)

Intersection ID: 26458	Main Street: BRECHIN_DR	Cross Street: BROADFORD_CT	Location:	N
ADA ID: F0BA80077818	Ramp Type: Perp	Initial Pass/Fail: Fail	Overall Compliance: No	Severity Score: 35
Codes/Mitigation Info/Possible Solution		Field Measurements/Component Compliance

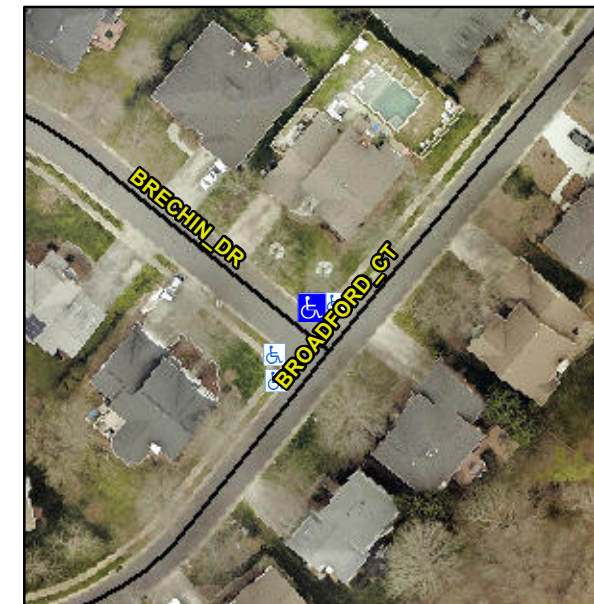
**N/A**

**Not Found, R304.5.1**

Compliance	Description	Data	Compliance	Description	Data
N/A	Ramp Length (in)	90.0	Yes	Ramp Slope (%)	7.5
No	Ramp Width (in)	25.0	Yes	Ramp XSlope (%)	0.2
N/A	Flare Type LT	N/A	N/A	Flare Type RT	N/A
N/A	Flare Slope LT (%)	N/A	N/A	Flare Slope RT (%)	N/A
N/A	Flare Traversable LT?	N/A	N/A	Flare Traversable RT?	N/A
N/A	Landing Length (in)	N/A	N/A	DWS Provided?	N/A
N/A	Landing Width (in)	N/A	N/A	DWS Contrast?	N/A
N/A	Landing Slope (%)	N/A	N/A	DWS Length (in)	N/A
N/A	Landing X Slope (%)	N/A	N/A	DWS Full Width?	N/A
N/A	Landing Curb? (Y/N)	N/A	N/A	DWS Offset (in)	N/A
N/A	Shared Landing?	N/A			
N/A	Gutter Ponding?	N/A	N/A	Gutter Slope (%)	N/A
N/A	Gutter Lip Ht (in)	N/A	N/A	Gutter X Slope (%)	N/A
N/A	Painted X Walk1?	No	N/A	Painted X Walk2?	N/A
	X Walk 1 Direction	To SW		X Walk 2 Direction	N/A
N/A	X Walk 1 Width (in)	N/A	N/A	X Walk 2 Width (in)	N/A
	X Walk 1 Slope (%)	0.2		X Walk 2 Slope (%)	N/A
	X Walk 1 X Slope (%)	2.0		X Walk 2 X Slope (%)	N/A

N/A	Ramp inside XWalk1?	N/A	N/A	Ramp inside XWalk2?	N/A
	Road Slope (%)	N/A	N/A	Clear Space?	N/A
	Road X Slope (%)	N/A	N/A	Clear Space to XWalk (in)	N/A
N/A	Any Obstructions?	N/A	N/A	Storm Grate/Utility Hazard?	N/A
	Obstruction Type			Storm Grate/Utility Type	
		N/A			N/A
			Yes	Surface Condition? (G/P)	Good

**Remove & Replace Entire Ramp.**

Total Cost: \$ 1850.00
