Access Compliance Report

Public Rights-of-Way

| Intersection ID: 31892 | Main Street: GREEN_MOUNTAIN_RD | Cross Street: LIFELINE_LN | Location: NE |
| ADA ID: F0BAF968E0C6 | Ramp Type: PerpDiag | Initial Pass/Fail: Fail | Overall Compliance: No |

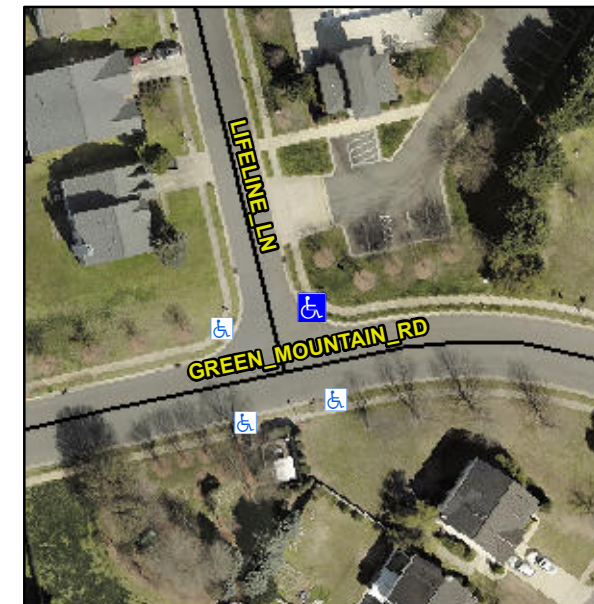
| | | Severity Score: 8.75 | |

R304.5.1

| Compliance | Description | Data | Compliance | Description | Data |
|---|---|---|---|---|---|
| No | Ramp Width (in) | 36.5 | Yes | Ramp XSlope (%) | 1.3 |

Remove & Replace Curb Ramp With Two New Directional Ramps or Equivalent.
