# Access Compliance Report

## Public Rights-of-Way

### (Curb Ramps)

Intersection ID: 27563	Main Street: BALLANTYNE_FOREST_DR	Cross Street: LEDERER_AV	Location: NW
ADA ID: F0CAF090BD4E	Ramp Type: Perp	Initial Pass/Fail: Fail	Overall Compliance: No
Severity Score: 13.75			
Codes/Mitigation Info/Possible Solution		Field Measurements/Component Compliance

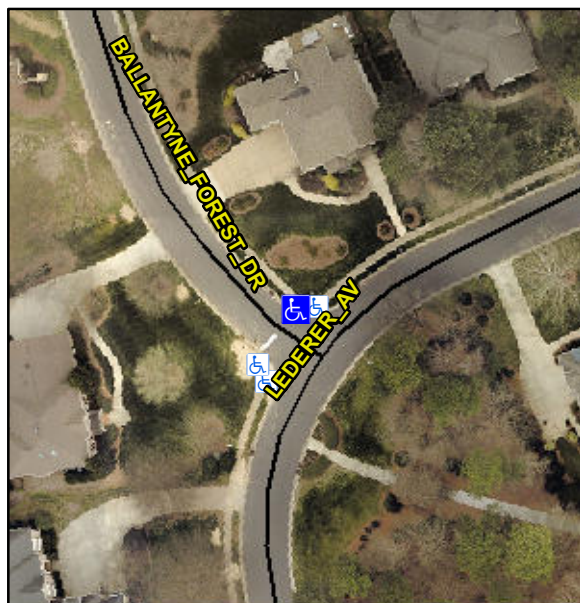
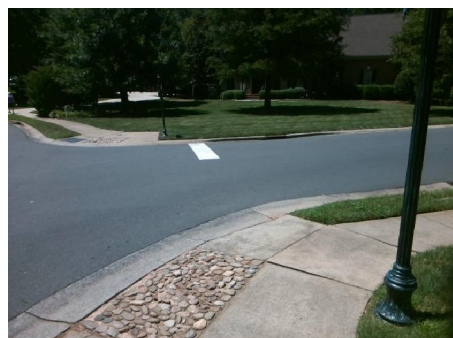
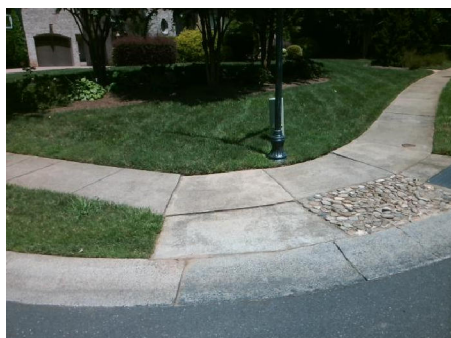
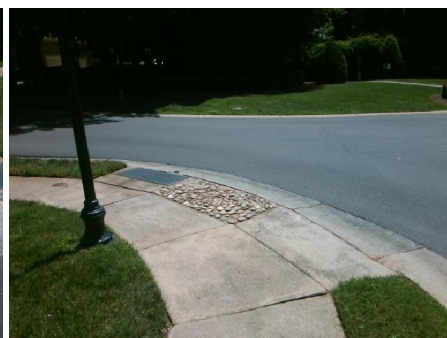
**Not Found, R304.2.2, R304.5.3**

Compliance	Description	Data	Compliance	Description	Data
N/A	Ramp Length (in)	34.0	No	Ramp Slope (%)	11.7
Yes	Ramp Width (in)	63.0	No	Ramp XSlope (%)	2.4
N/A	Flare Type LT	N/A	N/A	Flare Type RT	N/A
N/A	Flare Slope LT (%)	N/A	N/A	Flare Slope RT (%)	N/A
N/A	Flare Traversable LT?	N/A	N/A	Flare Traversable RT?	N/A
N/A	Landing Length (in)	N/A	N/A	DWS Provided?	N/A
N/A	Landing Width (in)	N/A	N/A	DWS Contrast?	N/A
N/A	Landing Slope (%)	N/A	N/A	DWS Length (in)	N/A
N/A	Landing X Slope (%)	N/A	N/A	DWS Full Width?	N/A
N/A	Landing Curb? (Y/N)	N/A	N/A	DWS Offset (in)	N/A
N/A	Shared Landing?	N/A			
N/A	Gutter Ponding?	N/A	N/A	Gutter Slope (%)	N/A
N/A	Gutter Lip Ht (in)	N/A	N/A	Gutter X Slope (%)	N/A
N/A	Painted X Walk1?	No	N/A	Painted X Walk2?	N/A
	X Walk 1 Direction	To SW		X Walk 2 Direction	N/A
N/A	X Walk 1 Width (in)	N/A	N/A	X Walk 2 Width (in)	N/A
	X Walk 1 Slope (%)	0.3		X Walk 2 Slope (%)	N/A
	X Walk 1 X Slope (%)	1.4		X Walk 2 X Slope (%)	N/A

N/A	Ramp inside XWalk1?	N/A	N/A	Ramp inside XWalk2?	N/A
	Road Slope (%)	N/A	N/A	Clear Space?	N/A
	Road X Slope (%)	N/A	N/A	Clear Space to XWalk (in)	N/A
N/A	Any Obstructions?	N/A	N/A	Storm Grate/Utility Hazard?	N/A
	Obstruction Type			Storm Grate/Utility Type	
		N/A			N/A
			Yes	Surface Condition? (G/P)	Good

**Remove & Replace Entire Ramp.**
