Access Compliance Report

Public Rights-of-Way

(Curb Ramps)

Intersection ID: 14278	Main Street: ROMARE_BEARDEN_DR	Cross Street: FARMER_ST	Location: NE
ADA ID: F0D2C7172217	Ramp Type: Perp	Initial Pass/Fail: Fail	Overall Compliance: No
		Severity Score: 12.5

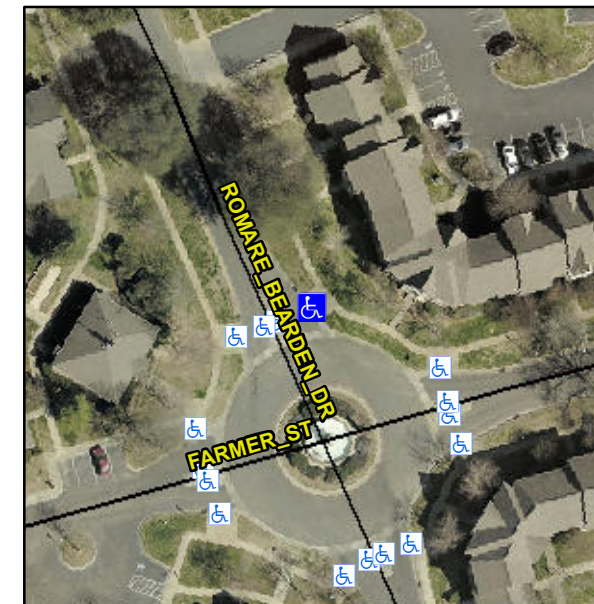
Not Found, R304.2.2

Compliance	Description	Data	Compliance	Description	Data
N/A	Ramp Length (in)	94.5	No	Ramp Slope (%)	9.8
Yes	Ramp Width (in)	50.0	Yes	Ramp XSlope (%)	0.7
N/A	Flare Type LT	N/A	N/A	Flare Type RT	N/A
N/A	Flare Slope LT (%)	N/A	N/A	Flare Slope RT (%)	N/A
N/A	Flare Traversable LT?	N/A	N/A	Flare Traversable RT?	N/A
N/A	Landing Length (in)	N/A	N/A	DWS Provided?	N/A
N/A	Landing Width (in)	N/A	N/A	DWS Contrast?	N/A
N/A	Landing Slope (%)	N/A	N/A	DWS Length (in)	N/A
N/A	Landing X Slope (%)	N/A	N/A	DWS Full Width?	N/A
N/A	Landing Curb? (Y/N)	N/A	N/A	DWS Offset (in)	N/A
N/A	Shared Landing?	N/A			
N/A	Gutter Ponding?	N/A	N/A	Gutter Slope (%)	N/A
N/A	Gutter Lip Ht (in)	N/A	N/A	Gutter X Slope (%)	N/A
N/A	Painted X Walk1?	No	N/A	Painted X Walk2?	N/A
	X Walk 1 Direction	To W		X Walk 2 Direction	N/A
N/A	X Walk 1 Width (in)	N/A	N/A	X Walk 2 Width (in)	N/A
	X Walk 1 Slope (%)	1.4		X Walk 2 Slope (%)	N/A
	X Walk 1 X Slope (%)	1.9		X Walk 2 X Slope (%)	N/A

Remove & Replace Entire Ramp.
